NDCRS SITE FORM ARCHITECTURAL SITES Page 1

| Field Code: ES-4 | page 2 | SITS # : 32ML |

A Cultural Resource Inventory of the Falkirk Mine Riverdale Extension, McLean County, North Dakota

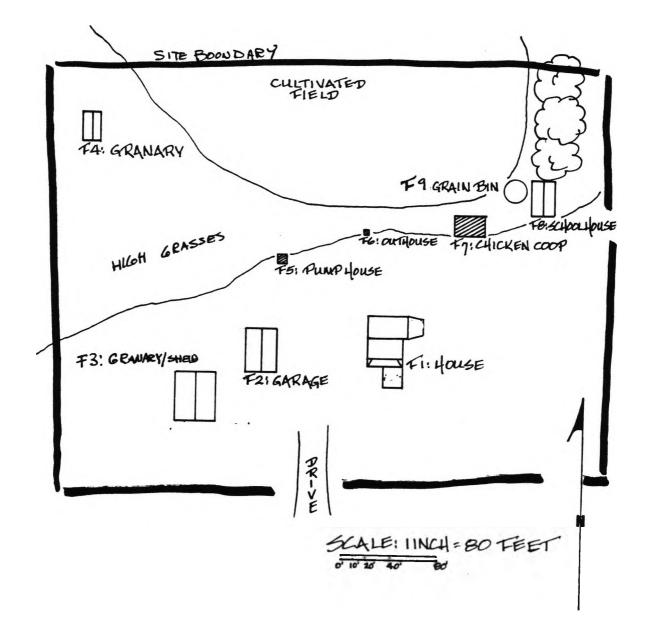
CONTOUR INTERVAL 20 FEET NATIONAL GEODETIC VERTICAL DATUM OF 1929 Field # : ES-4 SKETCH MAP

House- 1 Garage- 2 Granary/ shed- 3 granary- 4 well house- 5 outhouse- 6 chicken house 7 school house - 8 grain bin- 9

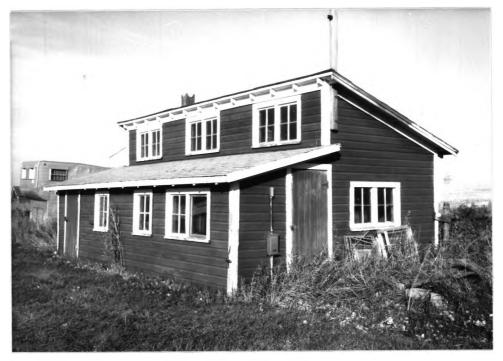
FEATURE 7: Chicken coop, south and east elevations, view to northwest

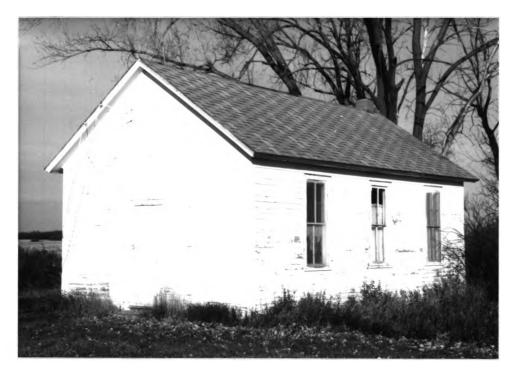
FEATURE 8: School House, south and east elevations, view to northwest

Feature 8 is a wood frame, rectangular school house placed on a low concrete foundation that adjusts to ground level, being highest under the north end wall. The schoolhouse is clad with weatherboard framed by cornerboards and has a gable roof covered with asphalt shingles and a metal ridgecap with end balls. The eaves are enclosed with molded cornice and wide flush boards. The east and west walls are symmetrical with three 2/2 double-hung windows. The south wall contains a centered four panel wood door and is approached by a concrete block stoop. A block chimney protrudes from the ridge near the north wall. According to Jerome Simfenderfer, this school house originally stood 1/2 mile to the west and was moved in by his father-in-law after 1945. The 1914 Ogle Atlas for T146N R83W shows a school house in the SW1/4 of Section 23 (Je Simfenderfer 1993; Ogle 1914b).

The schoolhouse has lost integrity of location, setting, feeling and association due to its removal from its original location. It has retained its historic fabric The building is not considered eligible under the established NR Criteria (A, B, C and D).
