### NDCRS ARCHITECTURAL SITE FORM PAGE 1

Field C	ode Park Township School #1	SITS# 32 ML

This feature is what remains of a one room school. The building was moved to the farm for storage and for use as a shop. An upper level and north room were added at a later date.

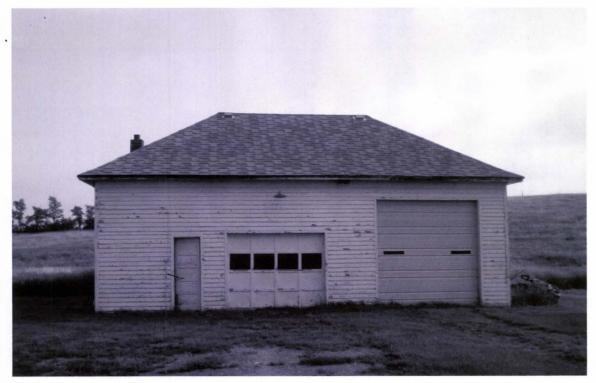
Park School #1

The interior was mostly gutted. There is evidence of lath and palster on the ceiling. Most of the ceiling had fallen in. On the south side of the building are two garage doors, installed at some point to give access for large equipment. There is electricity in the building today.

South Side

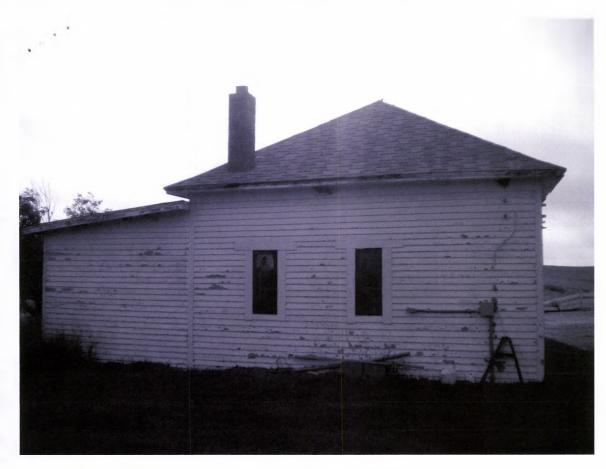
Park School #1

The school has asphalt shingles on the roof, 6 inch lap siding with 6 inch boards trimming the corners. There is chimney in the northwest corner of the building but I do not think it is original to the school. The school building was moved from a location 1/2 miles east. Originally located near the highway in Section 14. Two double hung windows on the east side and two newer windows on the west.

West Side 6/26/2012 Kathy Wilner
