NDCRS ARCHITECTURAL SITE FORM PAGE 1

Field Code Blue Hill School Site Name Blue Hill School

Project Title & Supervisor:
Country Schoolhouse Project

NDCRS ARCHITECTURAL SITE FORM
PAGE 3—Feature DataField Code Blue Hill SchoolSITS# 32 ML**Complete a Page 3 for each feature.****1. Feature Description, Integrity, Eligibility:**

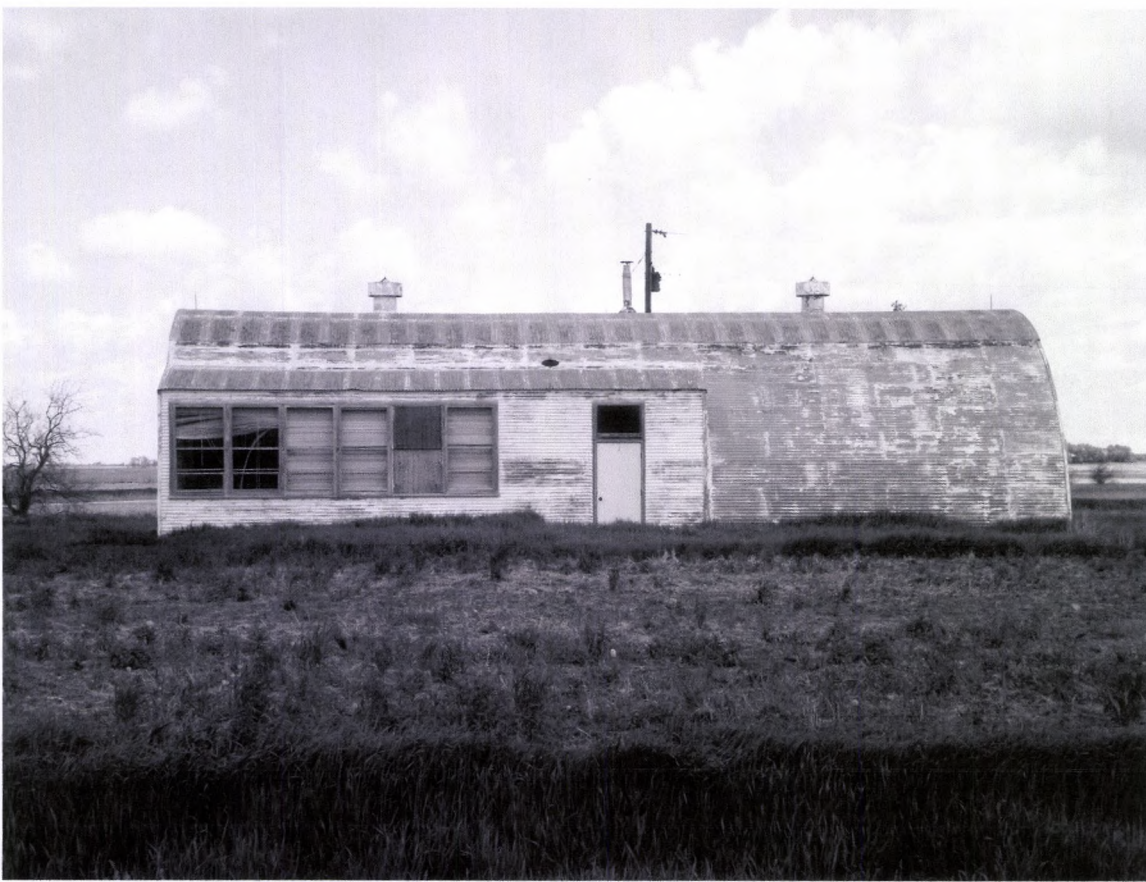
Blue Hill School South Side 06/01/2012 Kathy Wilner ML

The feature is a round raftered building that looks like a quonset. I learned that the previous school burned and was replaced with this building. It is fairly large and I think they would have had two classrooms from the size of the building. The entire building is covered with corrugated metal. The entry door to the school is on the south side and there is a transom window above the door. 6 double hung windows face south on the west end of the building. The west 1/2 of the south side of the building has an extended roof. On the west end of the building there are three more large double hung windows and two small ones toward the north side of the building. The north side shows a small bumpout as well as another entry door. The east end of the building has only two double hung windows. On the roof there are two ventilators and also a chimney for the furnace.
