NDCRS ARCHITECTURAL FORM
PAGE 1

Field Code Otis Township School

Country School House Project
Kathy Wilner
366 43rd Ave SE, Bowdon, ND 58418

**NDCRS ARCHITECTURAL FORM  
PAGE 3 – *Feature Data*****Field Code** Otis Township School**SITS# 32** ML 1401**Complete one Page 3 for each architectural feature at the site.****1. Feature Description, Integrity, Eligibility:**

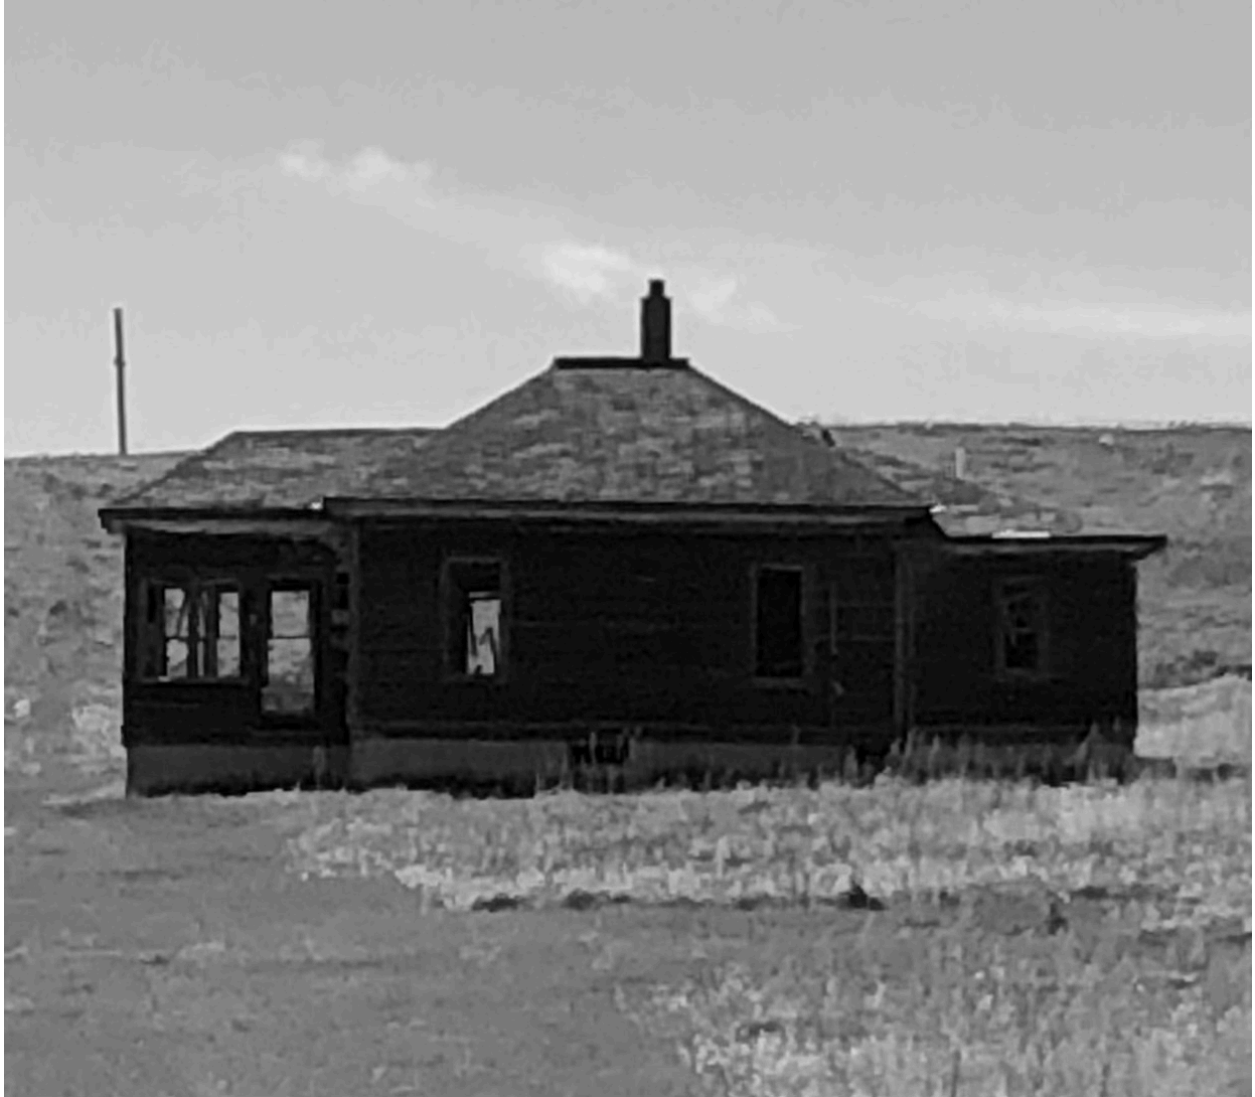
East Side

The siding is 6 inch wood lap with wood corner trim. From a distance, there are several double hung window openings. Two windows located on the east side, windows on both the north and south walls of the larger room, two windows on the east face wall of the south addition and three on the south wall of that same addition, one window on the east wall of the north addition and two more on the north wall of that same addition. A door on the north side leads into that addition and there is another door on the east wall of the south addition.
