NDCRS ARCHITECTURAL SITE FORM PAGE 1

Field Code Eliason School Site Name Eliason School

Project Title & Supervisor:
Country Schoolhouse Project

NDCRS ARCHITECTURAL SITE FORM
PAGE 3—Feature DataField Code Eliason SchoolSITS# 32 MO**Complete a Page 3 for each feature.****1. Feature Description, Integrity, Eligibility:**

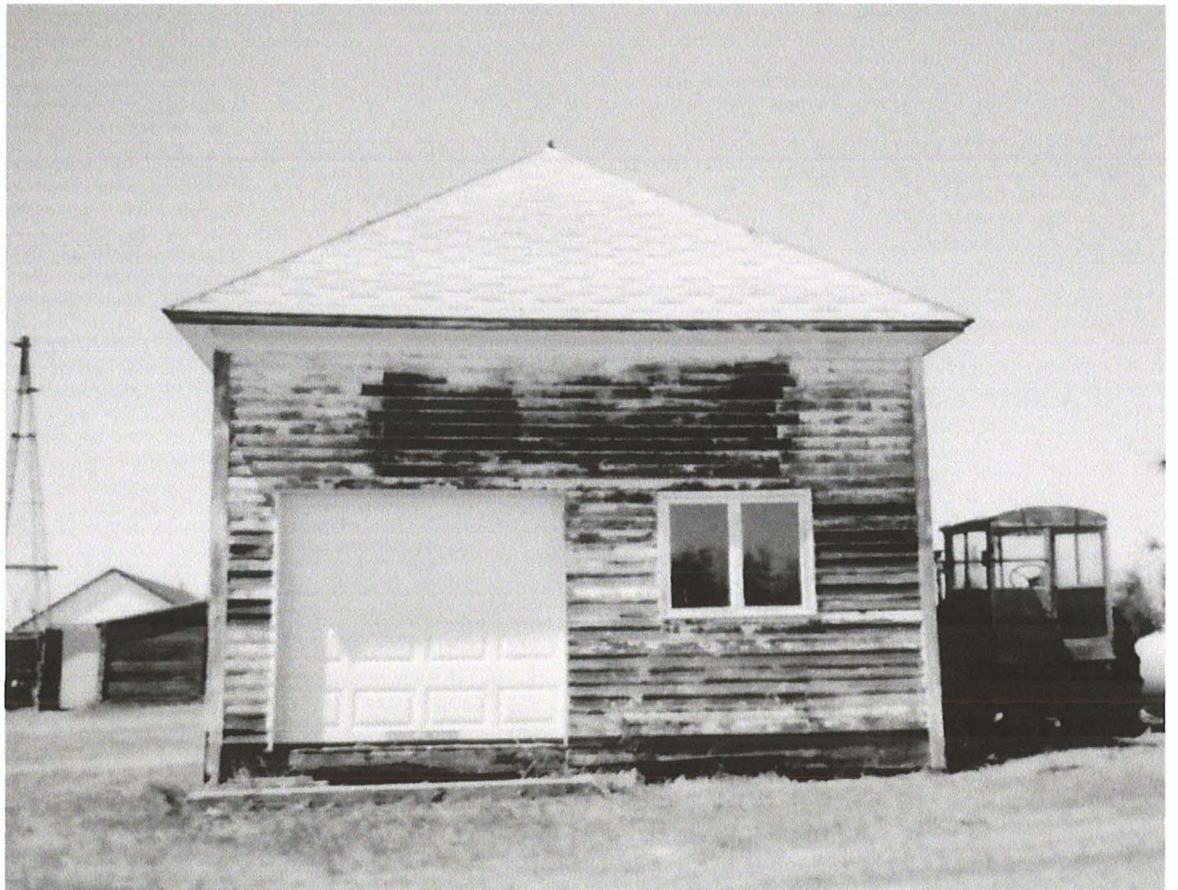
East Side

There is a wide trim board at the top of the siding on all four sides of the school. The remainder of the siding is 6 inch wood lap with 4 inch wood corner trim. There is a garage door on the east wall as well as a side sliding window with glass intact. The windows are all replacements. On the south side there are two newer double hung windows with intact glass and another similar window on the west side to the left of the entry door. The door is 5 panel wood with a storm door covering on the outside. There is a covered opening on the north side that might have been another window. The presence of a light fixture above the door would indicate the presence of electricity at some point. The walls and ceiling are finished with wallboard. The floor is tongue and groove hardwood. There are no blackboards or wainscot in the school. Most recent heat source was fuel oil.

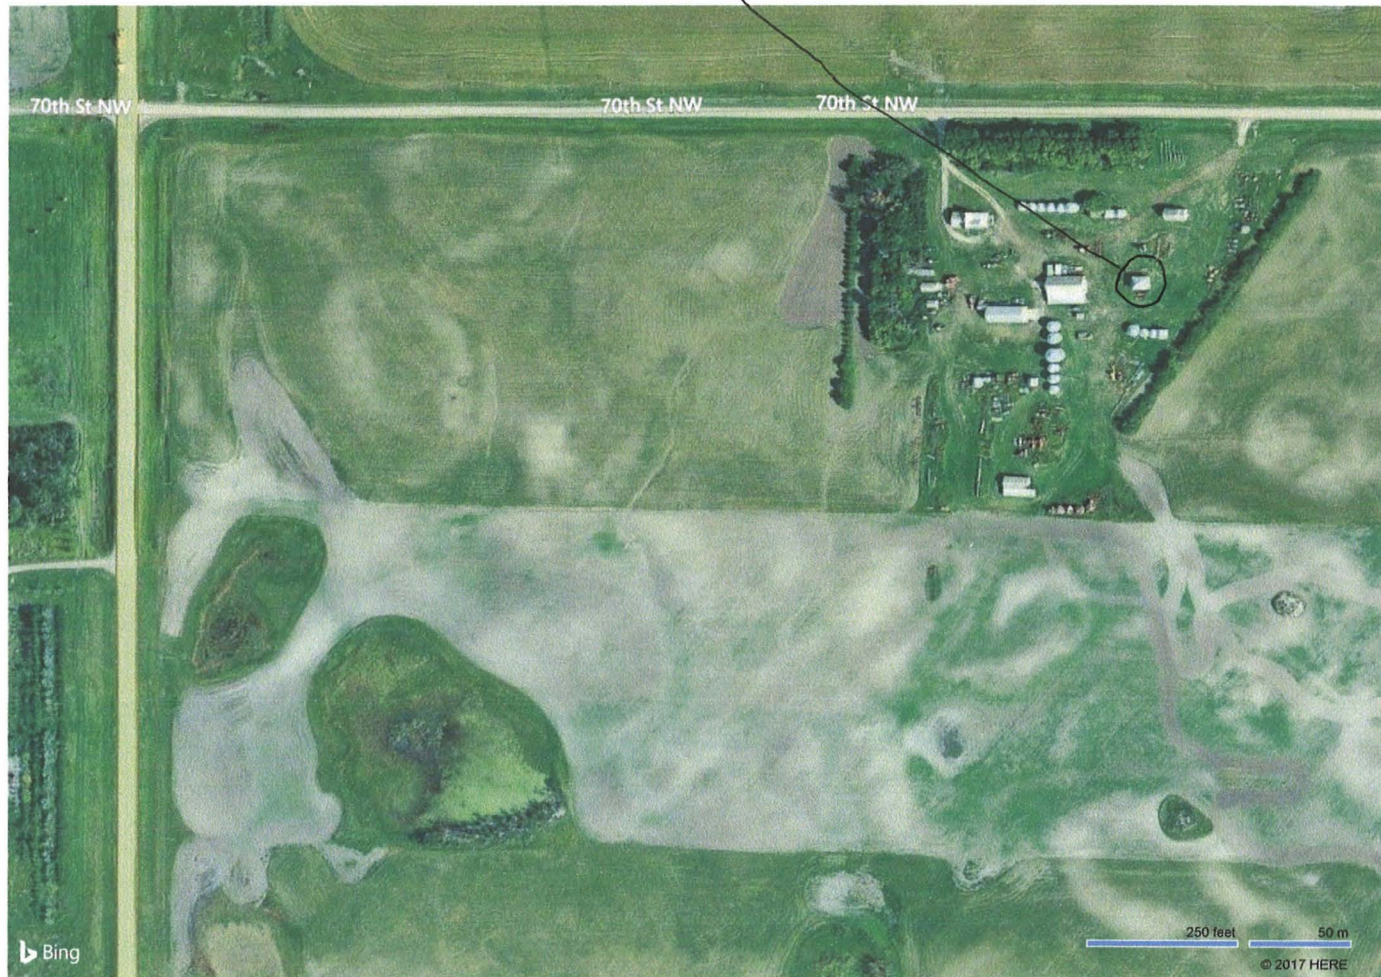
Feature

The feature is a one room prairie school sitting on a foundation of concrete blocks. The school was moved to this farm yard to be used for storage. Prior to this move the school had been used as a house. The hip roof is covered with asphalt shingles with metal capping and finials at the peak. There is a metal pipe chimney on the west slope of the roof. The soffits are closed with beadboard. The school measures 20 feet north to south and 24 feet east to west.
