### NDCRS ARCHITECTURAL SITE FORM

Field Code Banner School #2

**NDCRS ARCHITECTURAL SITE FORM****PAGE 3—Feature Data**Field Code SITS# 32 **Complete a Page 3 for each feature.****1. Feature Description, Integrity, Eligibility:**

The feature is a one room prairie school moved to this location from Section 9 of Banner Township.

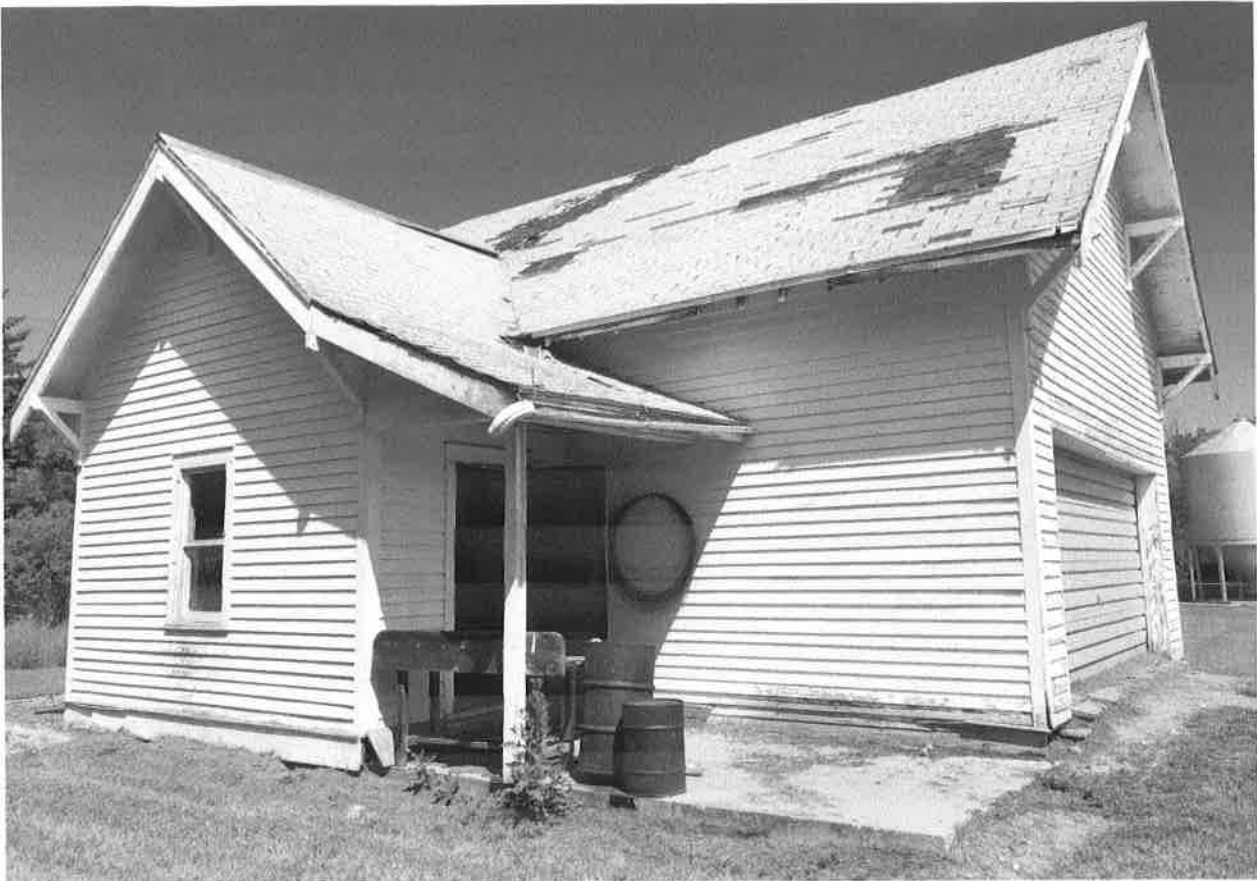
South Side

A rake board runs under the peak ends of the school and entry. The siding is 6 inch wood lap with 4 inch wood corner trim leading down to the waterboard and wide trim board at the bottom. There is an entry leading into the school with a 5 panel wood door. On the south side of the entry there is one one double hung window with glass. The floor in the entry is tongue and groove hard wood. At the west wall of the entry is a tall wood railing with a door opening to the left/south that used to lead to a basement in the school's past location. Walls in the entry and school are lathe and plaster with much of it falling away. A wide trim board runs around the rooms at the base of the wall. The east wall of the school has a double garage door to give access for a shop. Tongue and groove hard wood covers the floor in the main room of the school. There are three sets of multiply pane double hung windows on the north wall, some with some glass and most covered from the outside. Inside the school room two five panel wood doors can be seen at the west end, leading into the shed/bathroom addition. The south and east walls of the school room shows where the blackboard used to be, the chalk rail is still there. The ceiling is also lathe and plaster with much of the plaster fallen away. There is no wainscot in this school. The shed/bathroom on the west side has two 5 panel wood doors leading in to the little shed/lean-to. There are two small fixed pane windows to either side of that lean-to, both covered. The lean-to has a small opening on both the north and south sides, just under the eaves. There was no electricity, the hangers for lanterns are still hanging from the ceiling.

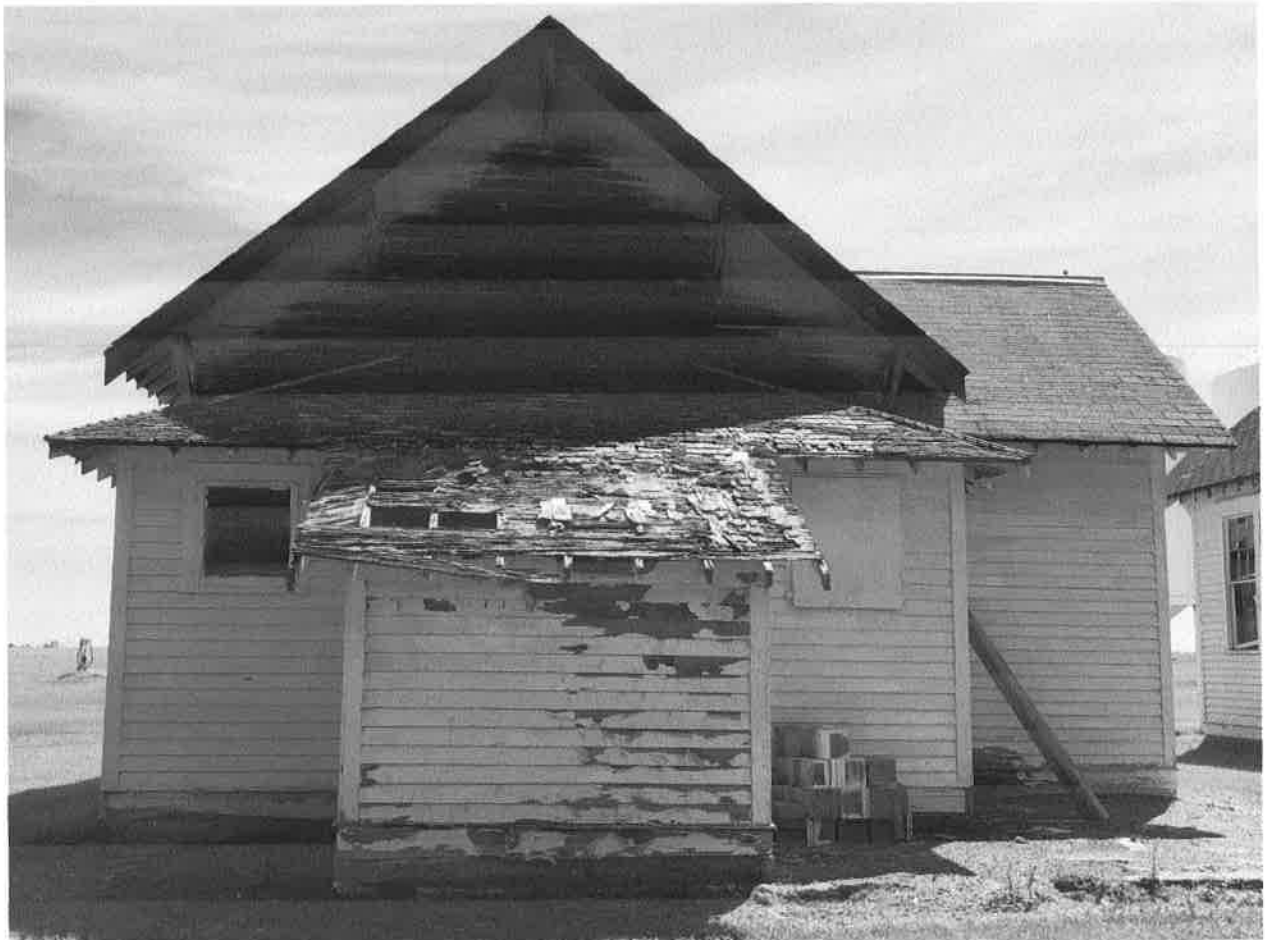
West Side

There is a shed/bathroom addition at the back, west side, of the school that measures 21 feet by 6 feet. At some point yet another small shed was attached to the west most addition. The roof on this addition is beginning to fall in and the shingles are in really bad shape. This small addition measures 8 feet by 6 feet and may have been used for storage. The entry measures 10 feet by 14 feet. Gable roofs cover the school and entry and a half hip roof is found on the shed/bathroom. The soffits are open with triangular shaped brackets lending support.
