NDCRS ARCHITECTURAL FORM
PAGE 1

Field Code Keene Township School

Country School House Project
Kathy Wilner
366 43rd Ave SE
Bowdon ND 58418

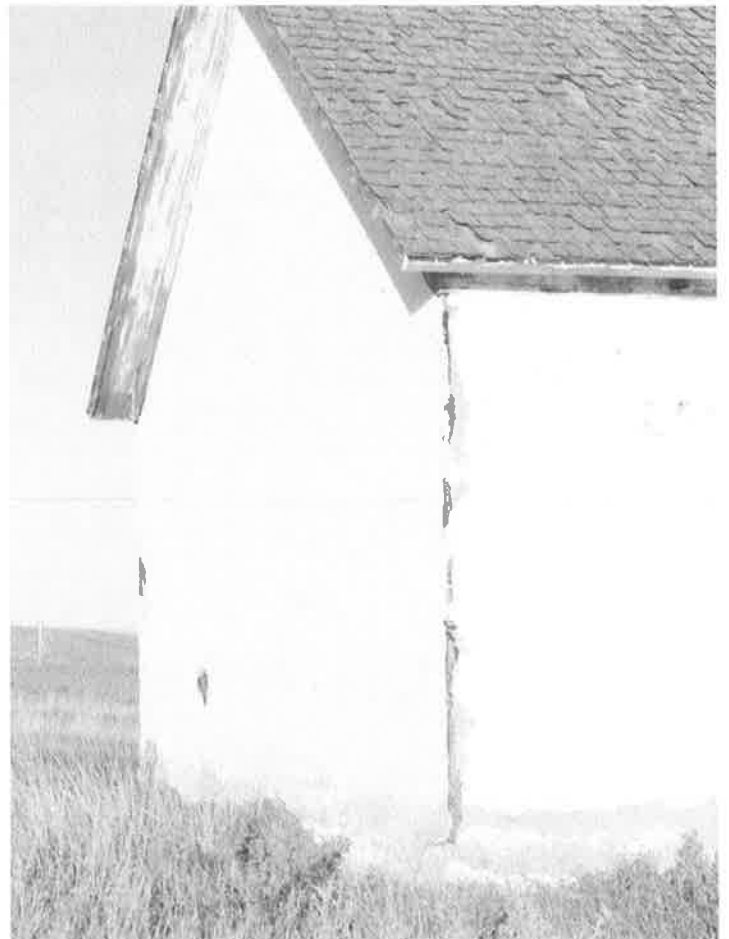
North Side

The roof of the school and and entry are covered with wood shakes. There is a red brick chimney on the north slope of the east/west running gable. Two pipes are located on the south slope of the roof near the west end. Metal capping and finials finish all the peaks. The soffists are closed.

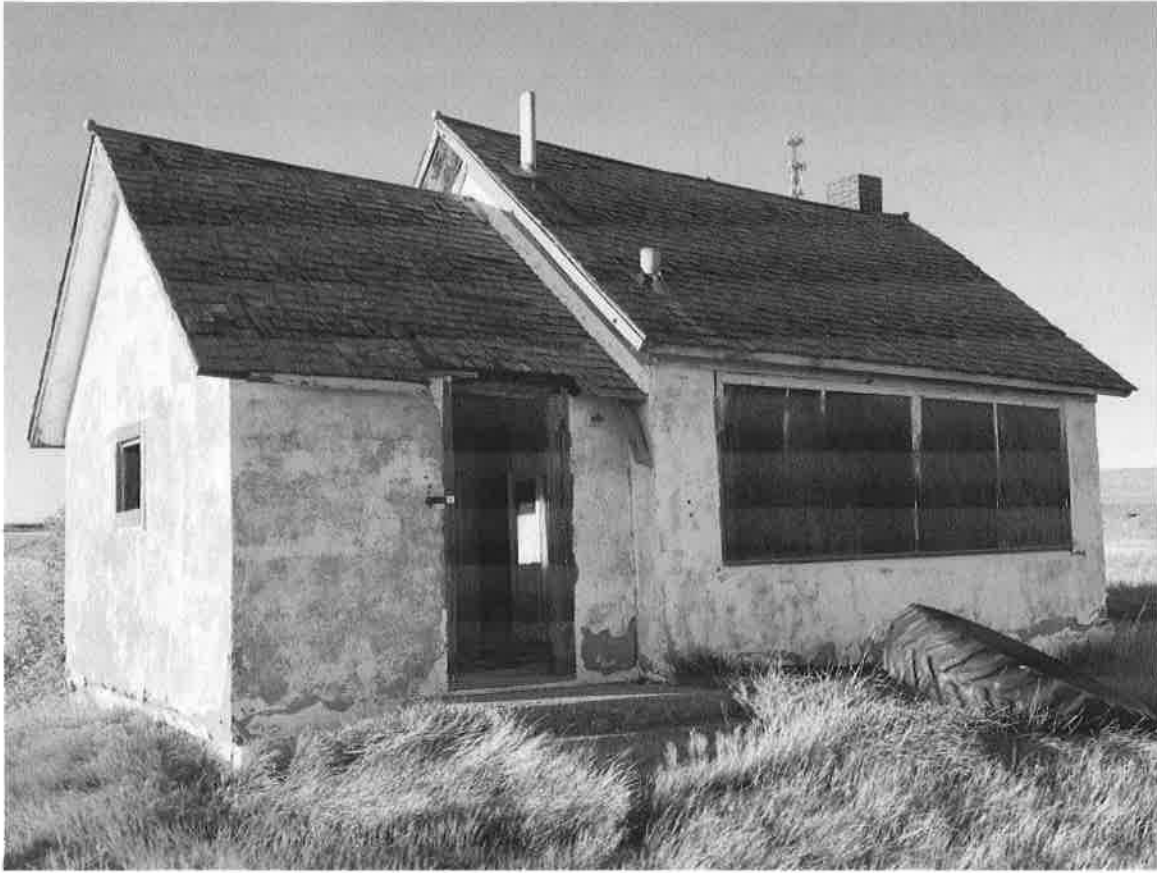
South Side

The siding is stucco over wood. All the windows have plywood shutters. Looking inside the school the windows are newer style double hung with intact glass. There is a small, fixed pane window in the entry. The entry has a south facing door opening reached from a three step concrete porch. There is a set of two windows on the east wall of the north addition as well as 4 larger windows on the south wall of the east/west room. The interior walls are buffalo board over wainscot. The entry walls are plywood. There is a heater located in the entry on the school side wall. The ceilings in both parts of the building were covered with sheet rock, both rooms have sloped ceilings. In the south part of the school much of the ceiling material has fallen. The floor is covered with linoleum and tile over hard wood. There is a blackboard on the west wall of the north addition. White flourescent light fixtures hang in the school. There are two windows in the basement on the south side.
