NDCRS ARCHITECTURAL SITE FORM PAGE 1

Field Code Christenson Township School Site Name _____
Site Name _____

Project Title & Supervisor:
Country Schoolhouse Project

NDCRS ARCHITECTURAL SITE FORM
PAGE 3—Feature DataField Code Christenson Township SchoolSITS# 32 PI**Complete a Page 3 for each feature.****1. Feature Description, Integrity, Eligibility:**

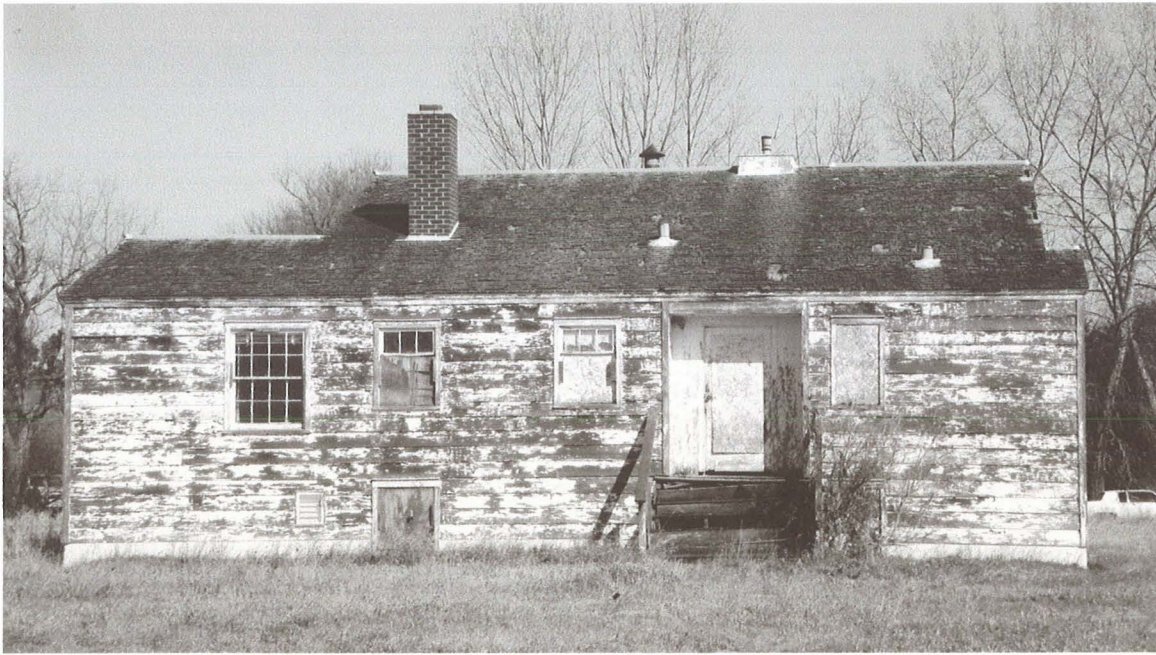
West Side

There are numerous windows in the school, the west side has a large, multipane double hung window in the north addition, 2 smaller multipane double hung windows just to the south of this. Parts of these windows are covered. Yet a third is to south of the door and it is covered as well. The door, inset opening, is plywood and reached by a set of wooden steps. On the south side of the school there are four shuttered openings that were most likely windows. On the north side of the north addition there is one small and one large multipane double hung window. On the east side of the school there is a bank of 6 very large, multipane (12 over 12) double hung windows with most of the glass intact. The top half of one was shuttered. Below this bank of windows there are 4 more multipane windows in the basement. Some shuttered. Electricity is present with wires running from a near power pole.

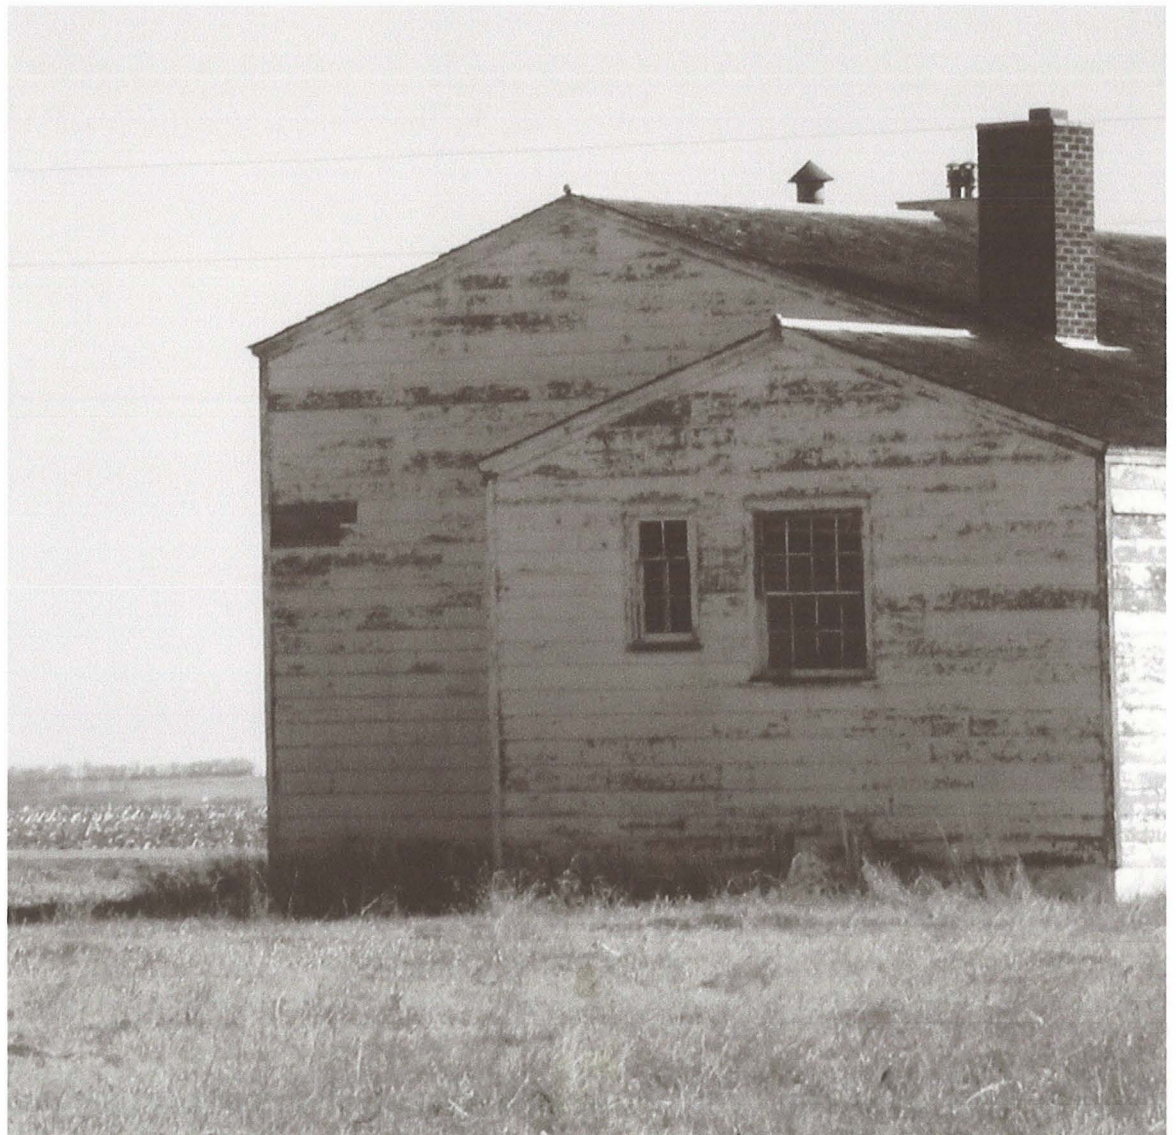
North Side

The gable roofs, main body, addition to the north and the smaller addition to the south all have wood shakes with metal capping and finials. Also on the roof of this building are various pipes, perhaps some for bathroom ventilation. A redbrick chimney is on the west facing slope of the roof nearer the north end of the school. There are no soffits, a trim board finishes the ends of the roofing. The siding planking with no lap involved. The corner trim is 4 inch wood.
