NDCRS ARCHITECTURAL FORM
PAGE 1

Field Code Hurricane Lake Twsp School #3

Country School House Project
Kathy Wilner
366 43rd Ave SE
Bowdon ND 58418

Feature Type 9 - School; Church school

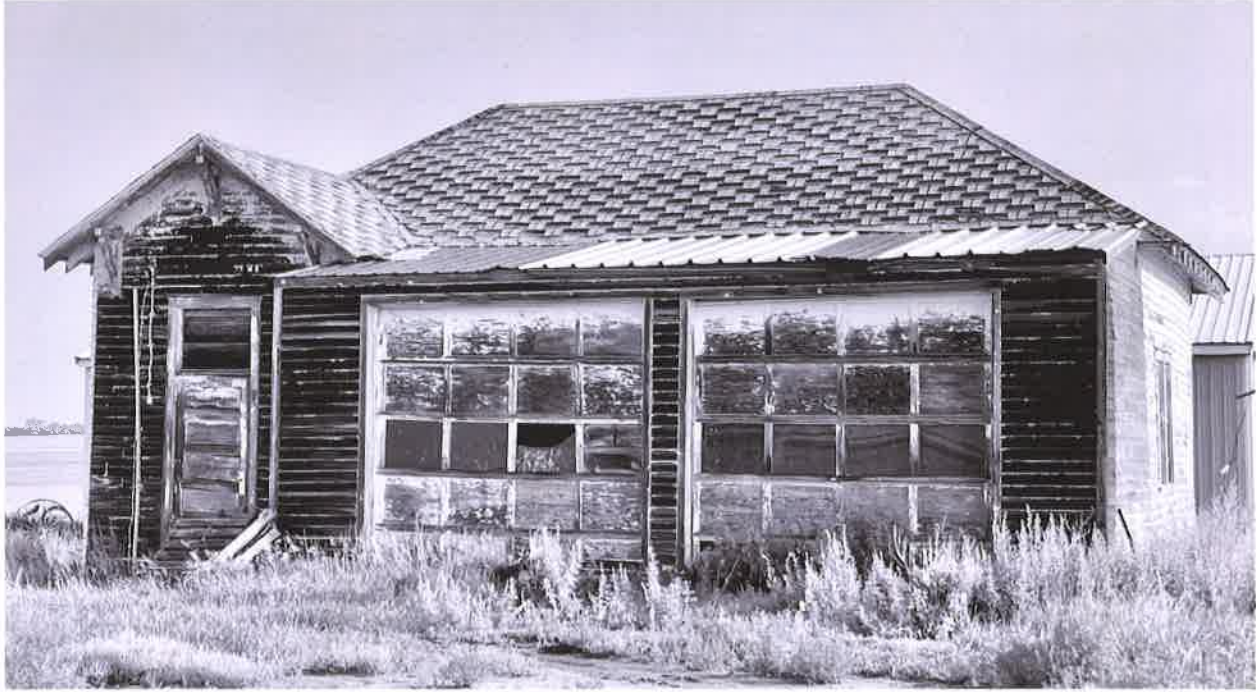
South Side

The siding begins with a rake board on all side of the school. The remainder of the siding is 6 inch wood lap with metal corner trim. Siding on the north side shows a straight line making me wonder if the school was enlarged. There are two, side by side, garage doors on the south side. The addition to the school allowed for deeper acces to the school and I think they removed a bank of windows on the original school house wall. The entry has a 5 panel wood door with an opening for a transom above it. There are three multipane, double hung windows on the west wall and two more on the east wall. All of them have some glass.
