NDCRS ARCHITECTURAL SITE FORM PAGE 1

SITS# 32_RI SITE IDENTIFICATION Field Code Sheyenne Township Hall Site Name Sheyenne Township Site Name Map Quad Wund Map Quad SEC __22__ QQQ <u>5</u>____ LTL __ TWP _ LTL ___ TWP __ SEC _____ QQQ _____ QQ __ SEC _____ QQQ __ QQ ___ LTL __ TWP _ LTL __ TWP _ SEC _ QQQ_ UTM _____ ZONE_ Subsection: NAD 1927 ___ NAD 1983 ___ UTM _____ $1 = N\frac{1}{2}$ $2 = E\frac{1}{2}$ City: McLeod $3 = 5\frac{1}{2}$ $4 = W\frac{1}{2}$ Street Number: $5 = NE\frac{1}{4}$ $6 = SE\frac{1}{4}$ Street Name: 154th Ave SE $7 = SW\frac{1}{4}$ $8 = NW\frac{1}{4}$ Urban Legal Description: SITE DATA Total # Architectural Features: _____1 Fieldwork Date: ____ 5/5/2016 Reconnaissance Survey ______ Intensive Survey ____ Project Title & Supervisor: Country Schoolhouse Project Report Title & Author(s): Additional Information: SHSND USE Verified Site _ Area of Significance __ Area of Significance . Ecozone -

Sheyenne Township Hall

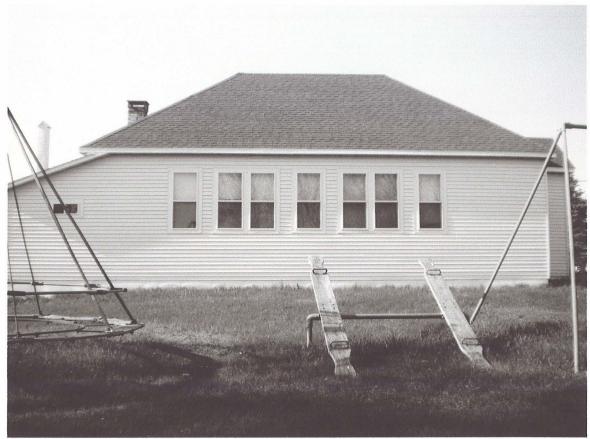
South Side

The siding on this school is new, steel siding in a pattern that replicates the 4 inch wood siding. The corner trim is also steel. There is a bank of 7 double hung windows on the south side, all double hung and with glass intact. They have storm windows with screens at the bottom covering the windows. There is one double hung window on the north, near the west end of the main body of the school. There are small, fixed windows on the walls of each bathroom, located on the north and south corners of the west addition. A small, double hung window is in the middle of the west wall. This window gives light into the room between the bathrooms that was the teachers quarters. The interior walls and ceiling are wall board and the floor is tongue and groove maple hardwood. The school also has wainscot. The floors have been refinished and they preserved some burn marks from the western part of the floor as this is where the wood stove used to be and sparks left the marks.
