NDCRS ARCHITECTURAL FORM PAGE 1

Field Code Elma Township School #1

Architectural Feature # 1

1. Feature Description, Integrity, Eligibility:

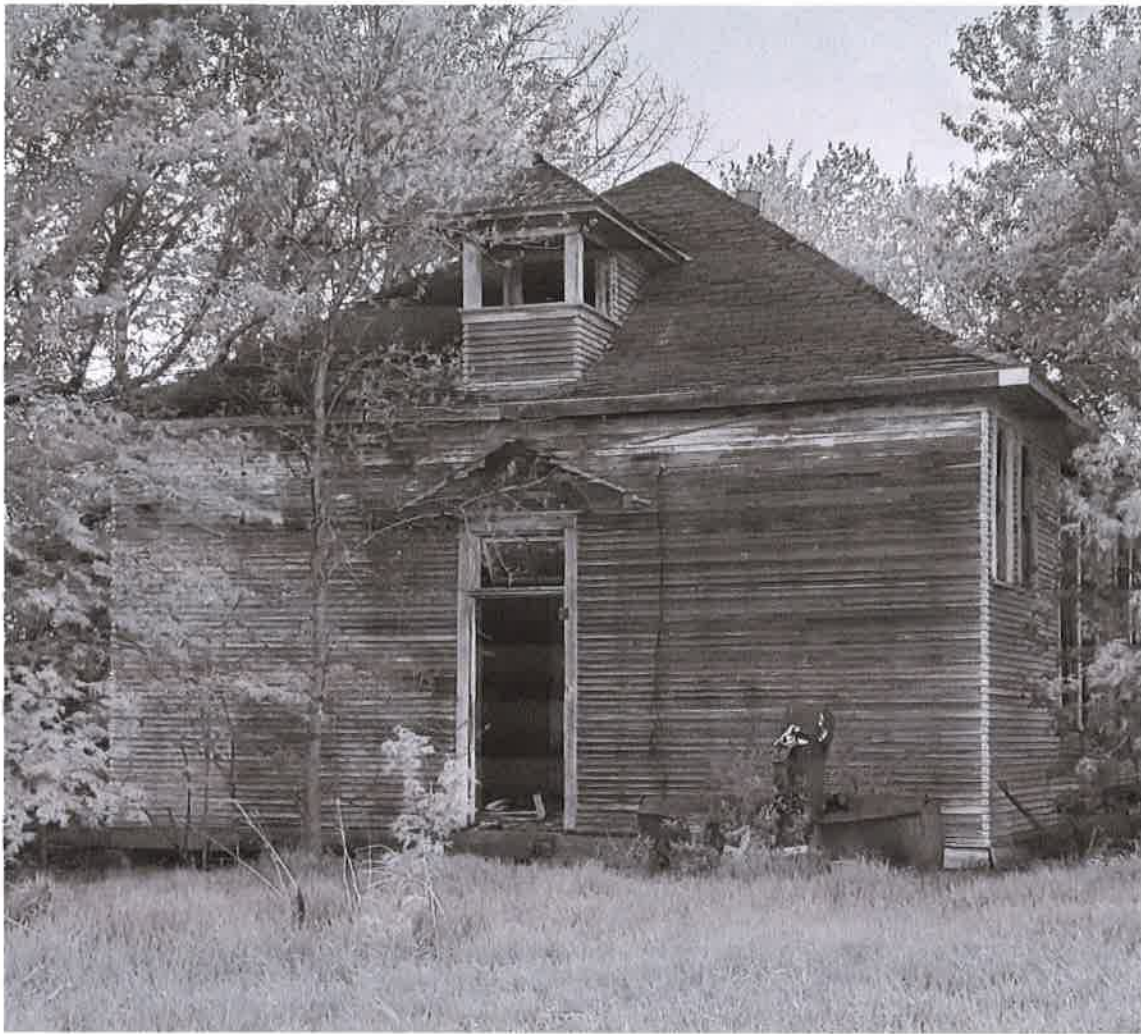
East Side

The feature is a one room prairie school place on a concrete foundation when it was moved into a farm yard. The building was moved to be used for grain storage. The hip roof is covered with asphalt shingles. There is a hip roofed dormer bell tower on the east slope of the school with openings on three sides. The roof of the bell tower has wood shakes with metal capping and one finial.

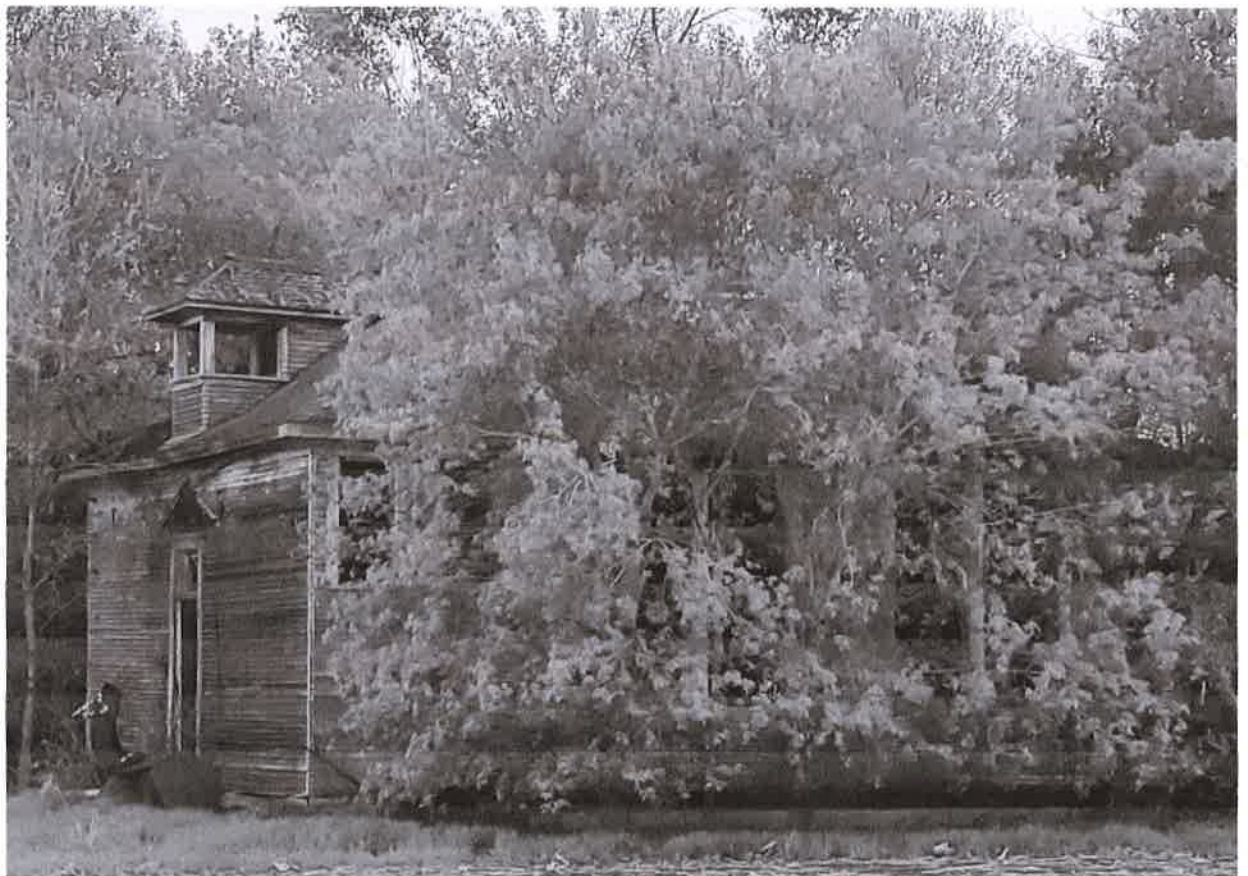
North Side

The siding on the school begins with a rake board under the eaves on all sides. The rest of the siding is 6 inch wood lap with metal corner trim. A water board can be seen on most walls. The wall on the south side of the school has large holes to the outside of the building. There are two smaller double hung window openings near the east end of the north and south sides of the school that are found in the coatrooms, all with no glass. The remaining larger double hung window openings are found on the north side of the school, some covered, little framing and no glass. There is still lathe and plaster on parts of the walls in the entry as well as the school room. A picture rail can be seen on the walls in the school room. The ceiling is completely gone in the school room while some remains in the coat rooms. There is evidence that an entry used to be attached to the school. A door opening leads into the school with the coat rooms to either side. Above the door opening is a transom window with glass. Another door opening into the main school room also has a transom, this one without glass. The floor was tongue and groove hard wood but much of it is gone after being used for grain storage.
