NDCRS ARCHITECTURAL FORM
PAGE 1

Field Code Sime School

Site Name Sime School

Reconnaissance Survey

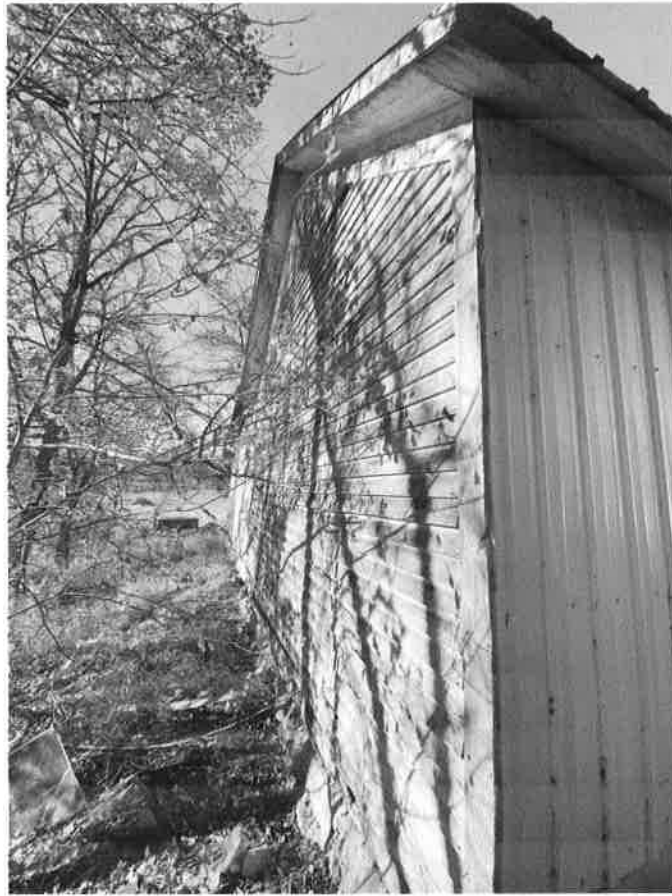
South Side

A rake board begins the siding under the eaves at the peak ends of the school. The siding on the north and south walls is wood lap siding with wood corner trim. The east side was covered with horizontal metal siding. There are two newer windows on the east wall. There are three double hung windows on the west wall inside the school that look into the garage addition. The interior walls are a combination of beadboard and wallboard. The ceiling is beadboard. There is some wainscot. The blackboards were removed. Electricity is present. The floor was replaced.
