NDCRS SITE FORM
ARCHITECTURAL SITES

Field Code FV-42 Site Name SCHOOL/MWA HALL
Field Code _____ Site Name MACHINE SHOP

NDCRS ARCHITECTURAL SITE FORM

Field Code: FV-42

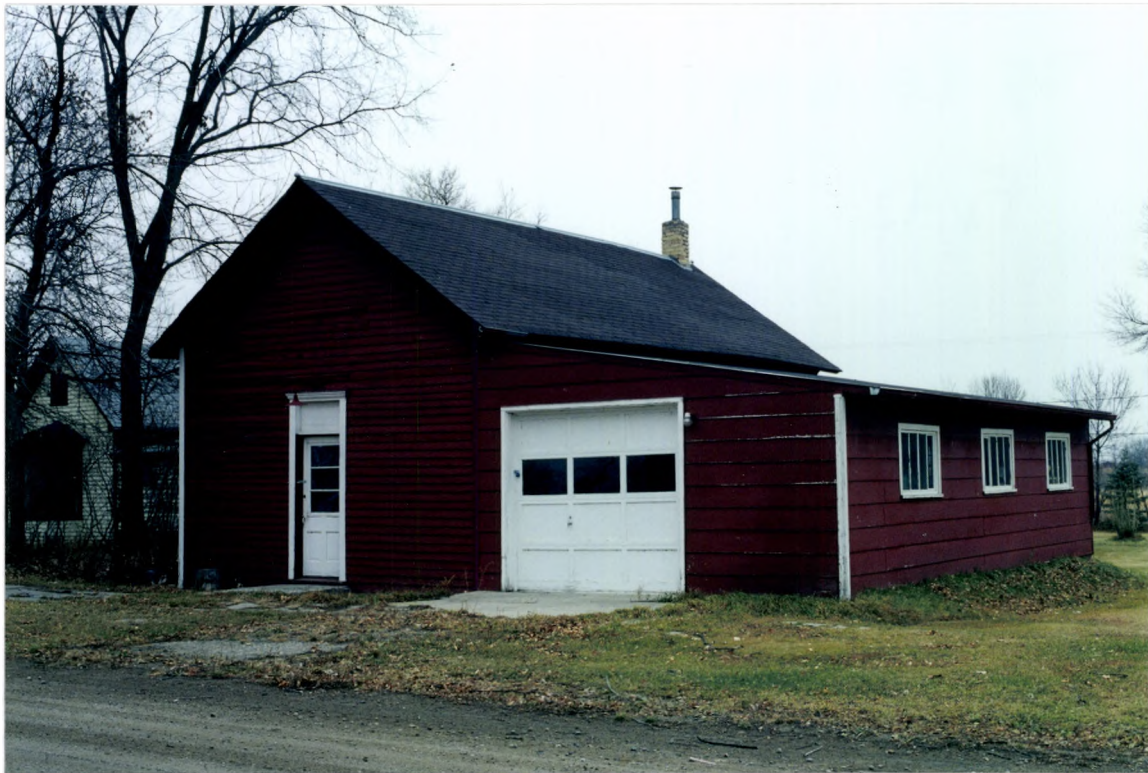
Photo I.D. Code: 99CF11-4

View toward the Northeast, showing the front (West) and South facades. The shed-roofed addition on the south dates from the 1960's.

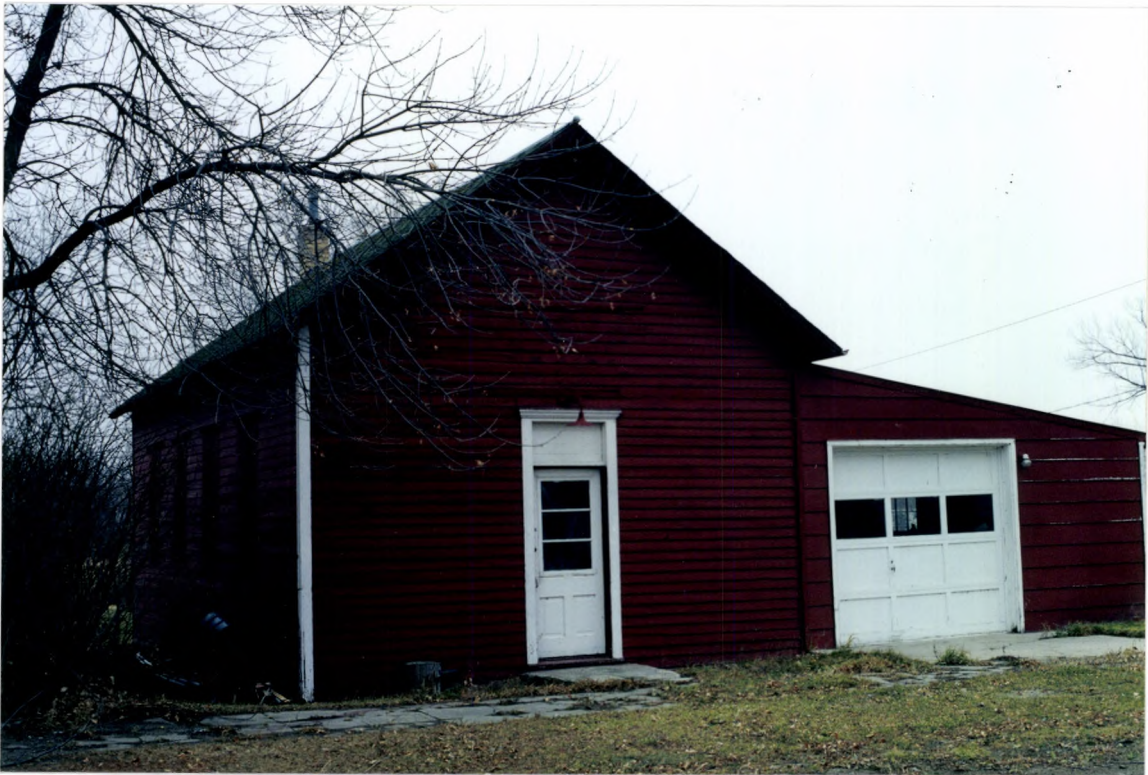
Photo I.D. Code: 99CF11-5

View toward the Southeast, showing the front (West) and North facades.

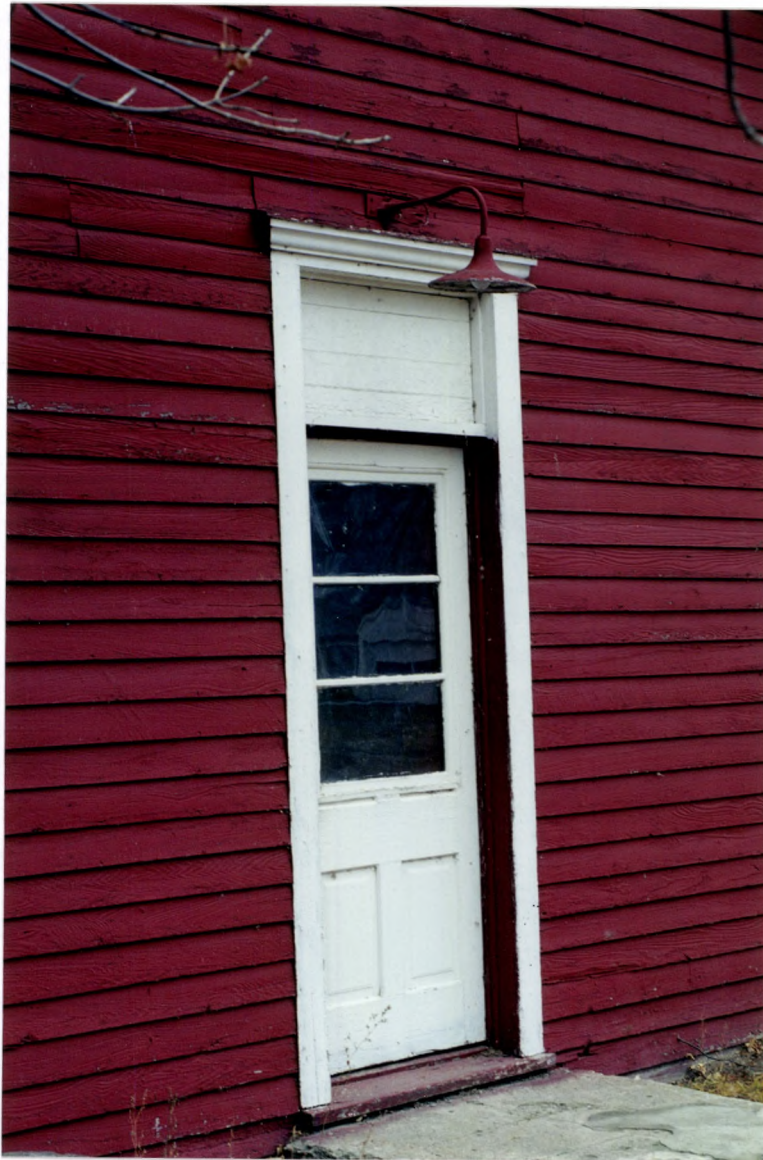
Photo I.D. Code: 99CF11-6

Detail of the front door on the front (West) façade, showing what appears to be the original door frame. The overhead light probably dates from the lodge hall era.

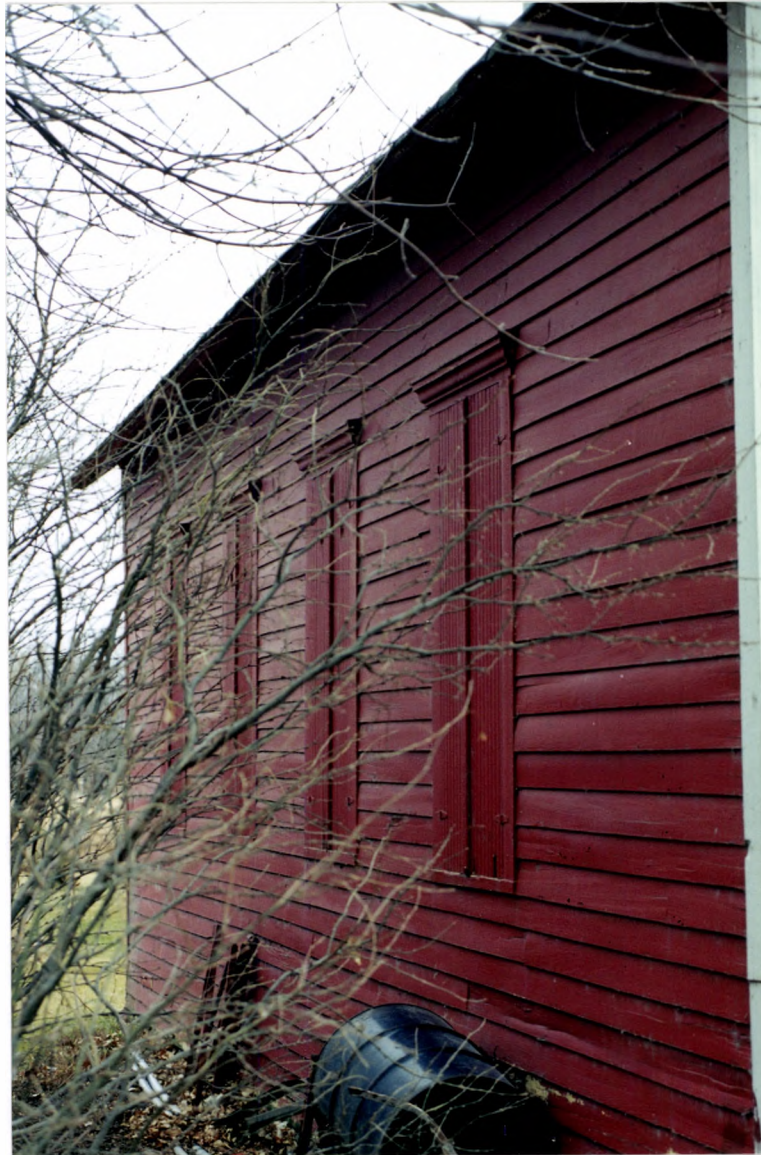
Photo I.D. Code: 99CF11-7

Frames on north wall intact but covered by closed shutters

View toward the Southeast, showing the North wall with its four shuttered window frames.

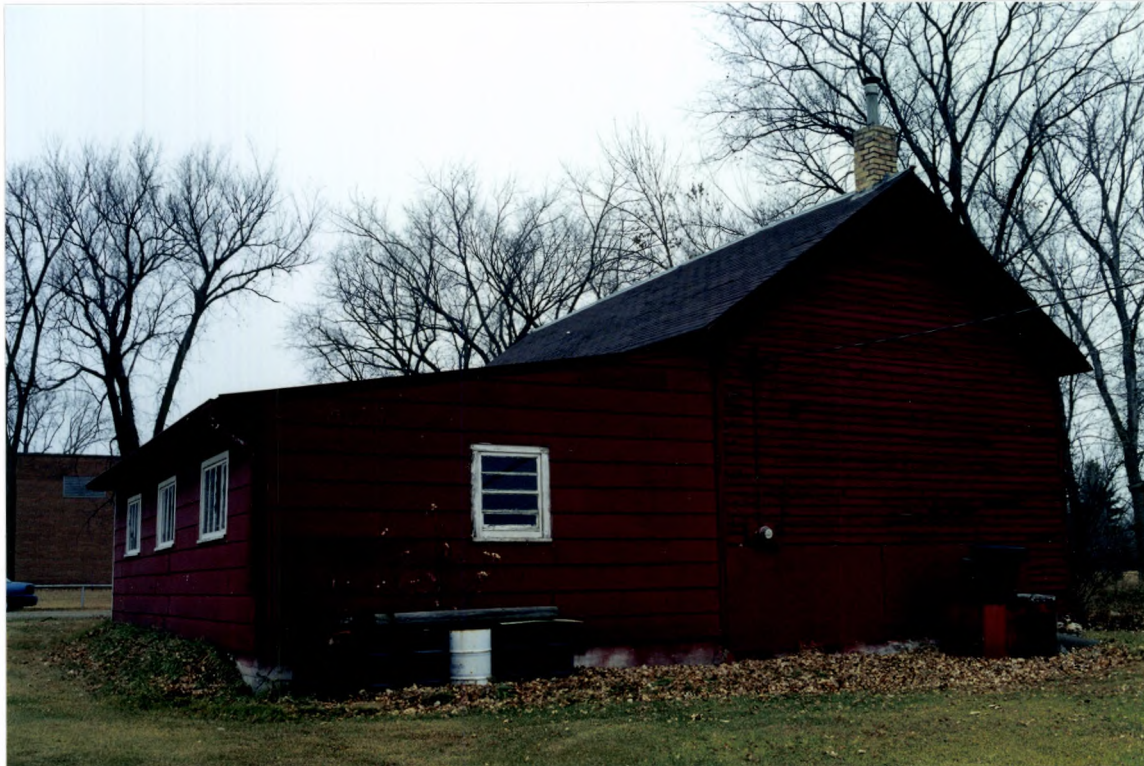
Photo I.D. Code: 99CF11-8

View toward the Northwest, showing the rear (East) and South facades.

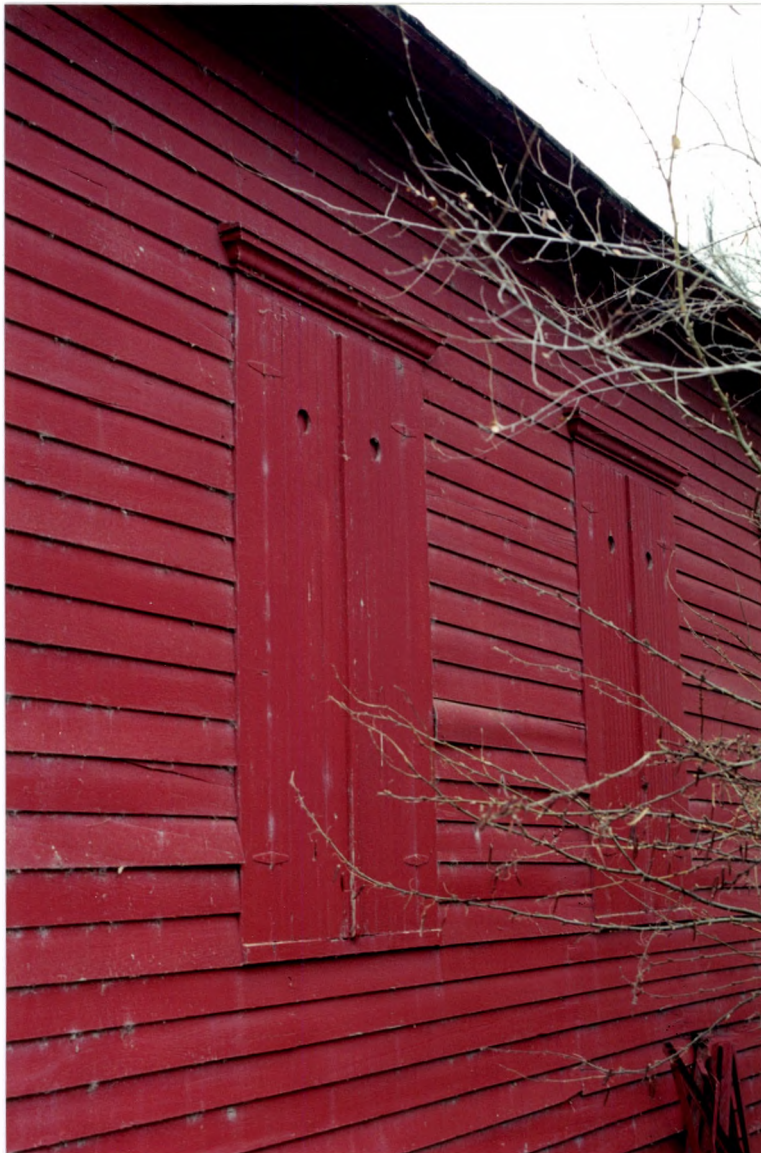
Photo I.D. Code: 99CF11-9

Detail of two of the shuttered window frames on the North façade.
