NDCRS ARCHITECTURAL SITE FORM PAGE 1

Recorded By Katny Wiln (First Name & Last Name)		Date Recorded	(mm/dd/year)
Area of Significance Kathy Wiln	er	Data Pacardad	1/16/2014
SHSND USE Area of Significance Area of Significance Ecozone	Verified Site Non-Site —		2
Additional Information:			
Report Title & Author(s):			
Country Schoolhouse Project			
Project Title & Supervisor:	,		
/	sive Survey		
Total # Architectural Features: 1 Fieldwork Date: 10/25/2013			
SITE DATA			
Urban Legal Description:			
			7 = SW½ 8 = NW¼
Street Number: 1651			5 = NE½ 6 = SE¼
City: Goodrich ND			$3 = S\frac{1}{2}$ $4 = W\frac{1}{2}$
UTMN	ZONE . NAD 19	927 NAD 1983	Subsection: 1 = N½ 2 = E½
LTL TWP R SEC LTL TWP R SEC	QQQ	QQ	<u>a</u>
Map Quad #		s 00 6	Q <u>7</u>
Map Quad Mertz Slowsh			
Field Code Mertz Township School #1	Site Name Me	rtz Township School 🕮	
SITE IDENTIFICATION

This feature is a one room, wood framed prairie school house. It was moved about 1/2 mile from the east to the Stober farm yard to be used as a shop. The roof of the building is covered with green metal sheeting. There is no longer a chimney. Siding on the building is wood lap with wood trim boards at the corner, all painted red. A

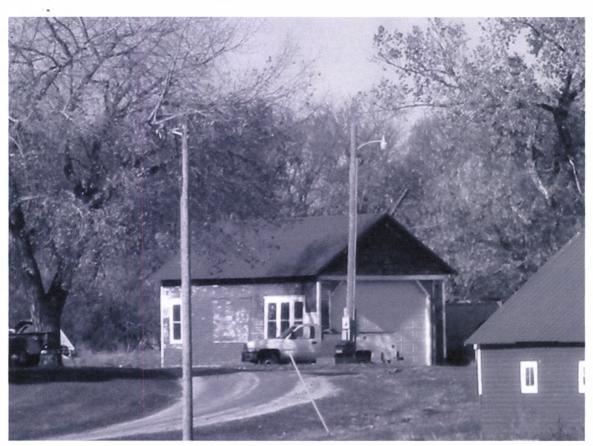
There is a bank of three windows toward the east end on the south side. They look to be double hung and all the glass in intact. Toward the middle of the building two or three windows have been replaced by lap siding. Near the west end of the south side there is another double hung window with the glass intact. The placement of that window makes me wonder if there was an entry at the west end of the building. There is no door on the west but it looks like they boarded in an opening on that wall.

South and East Sides
Mertz Township School #1
West Side
