NDCRS ARCHITECTURAL SITE FORM
PAGE 1 UPDATE

NDCRS SITE FORM
ARCHITECTURAL SITES

Base Data Form

SITE 13 PAUL MARGTET FARM

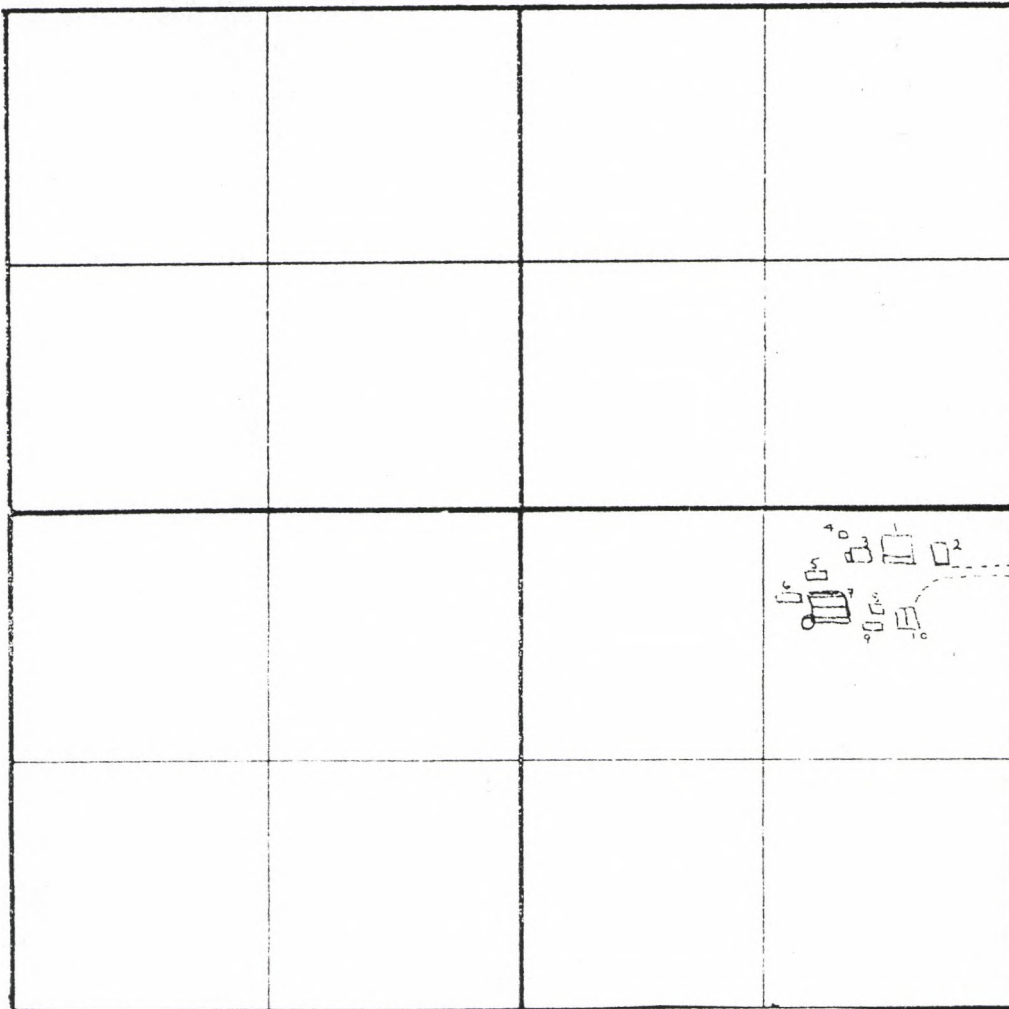
20. Sketch Map of Site:

See Page 3 for Key

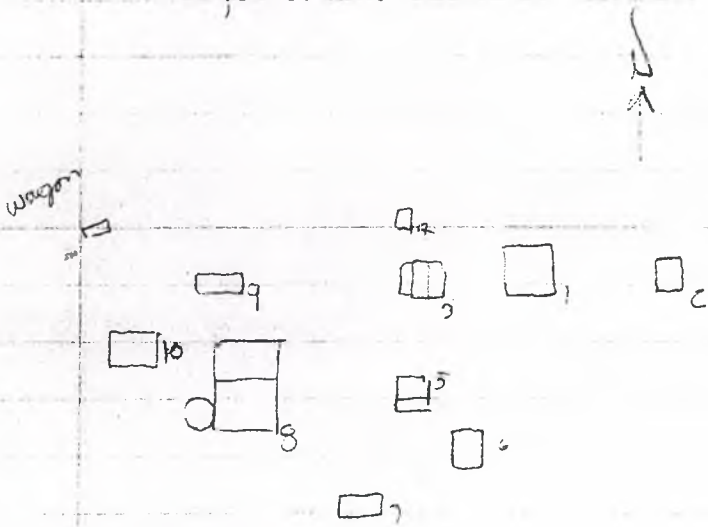
Site 13

- 1 Main House
- 2 School House / Garage
- 3 Summer Kitchen + add on
- 4 out house
- 5 work shed
- 6 Garage
- 7 chicken coop
- 8 Barn / silo
- 9 granary
- 10 Cattle shed / possibly earlier barn

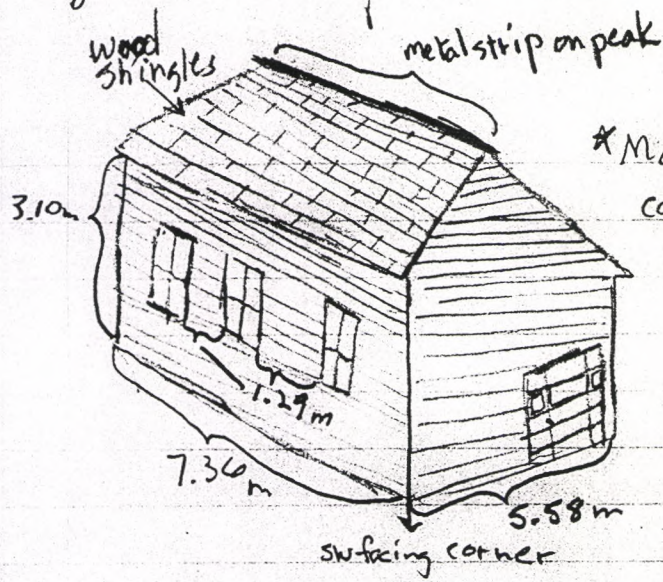
* Magstadt - school house converted into garage
 Wood side - half tongue construction - 13cm high siding - 1m 41cm long siding
 Garage door 2m 30cm high, 2.96m wide
 Windows in garage door measure 60cm

long by 34cm high for two end windows - center window 1.23m long 34cm high - Three windows on E & W facing sides of building - center window on E side boarded up
 Side windows measure 1.77m tall by .97m wide
 Window in center 1.29m from end windows - Building width 5.58m length 7.36m - Side walls 3.10m tall
Interior: No windows N wall -

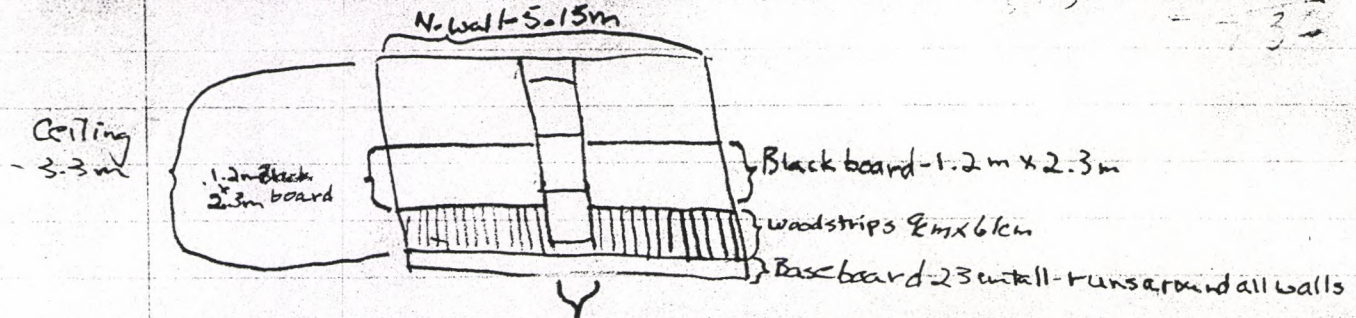
Former chimney .55m x 3.3m to ceiling - chimney is taller than ceiling

Vertical Wood strips line S, E & W walls from below baseboard - Measured from top of baseboard to ^{bottom of} capping 7cm high horizontal wood 1.13m tall on S, W & E walls - on N wall vertical strips stop at bottom of chalk board - measured from top of baseboard to bottom of chalk board 61cm tall - Vertical strips have decorative ridge in center:

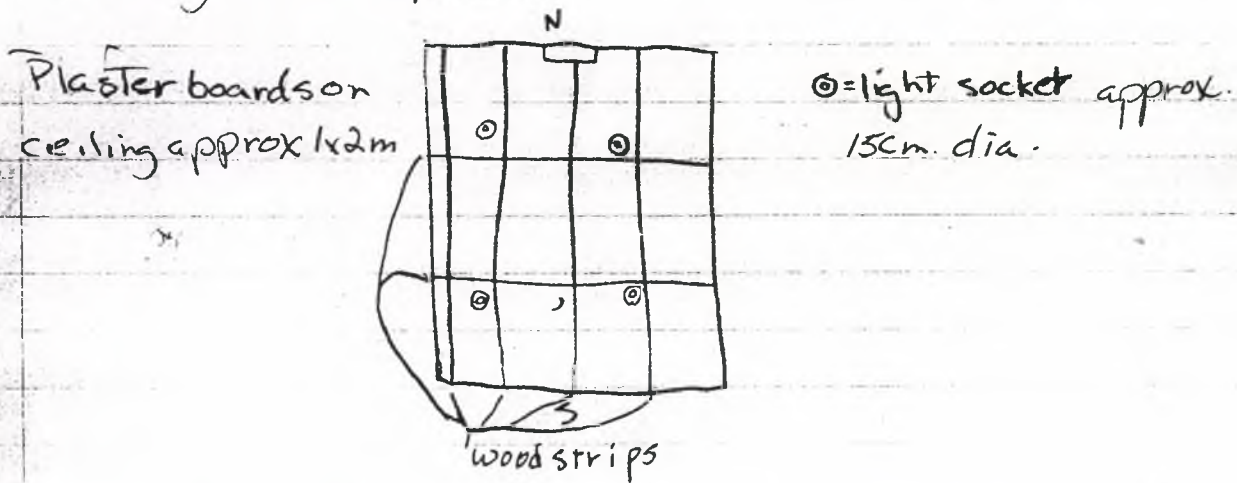
Capping horizontal strip is 7cm tall 1.11m long between windows and 1.01m long between end windows and N/S walls - above wall strips building is plaster board
Ceiling is also plaster board see illustration

Under plaster board & vertical strips on walls is underlying horizontal wood strips approx. 4cm tall & 1.2m long. Behind horizontal strips are horiz. planks, 21cm high, length unknown - Under the vertical decorative strips on the lower walls the thin horizontal strips are spread with a covering of plaster or cement.

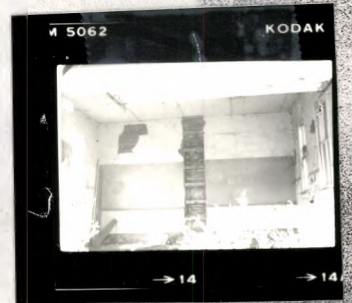
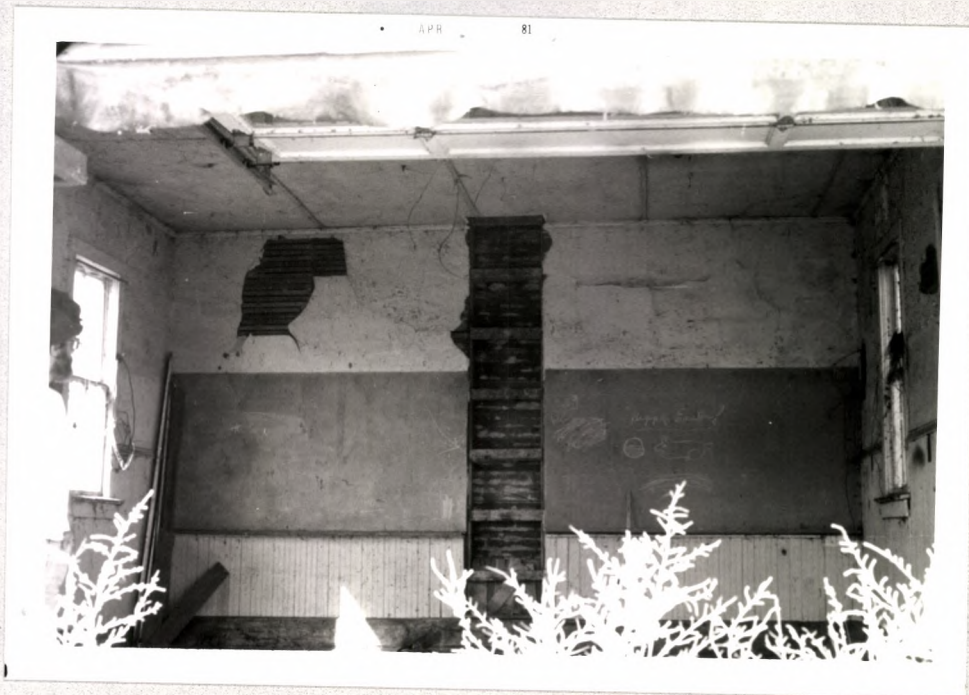
Negative No: 13A

school house, interior, inside of
north facing wall

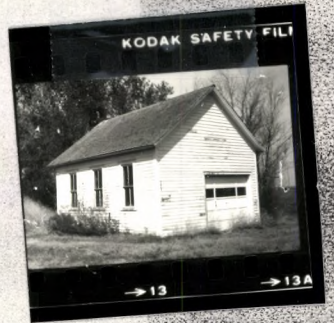
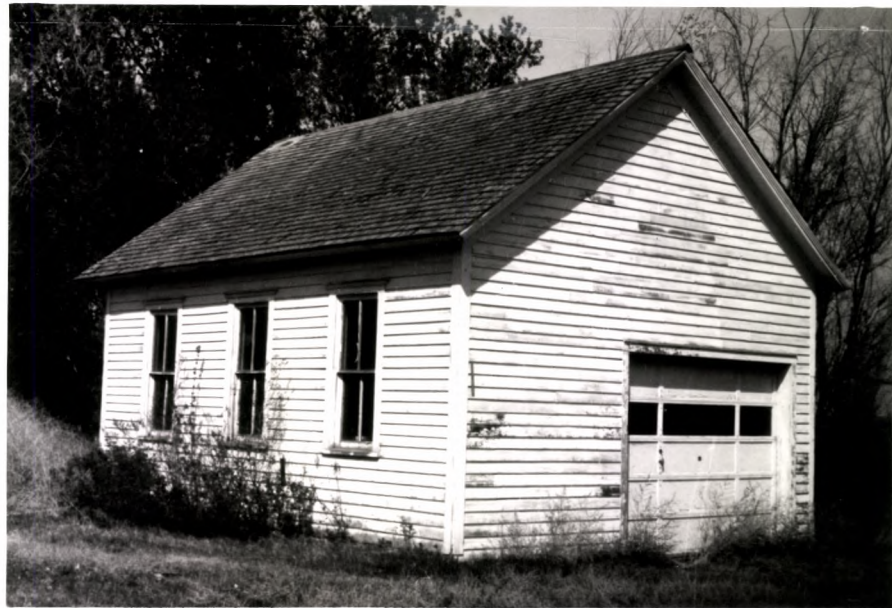
Negative No: 12A

Schoolhouse - south and west-
facing walls. Maastedt.
