NDCRS ARCHITECTURAL SITE FORM PAGE 1

Field Code Hanson School Site Name _____

Project Title & Supervisor:
Country Schoolhouse Project

**NDCRS ARCHITECTURAL SITE FORM
PAGE 3—Feature Data**Field Code Hanson SchoolSITS# 32 WE**Complete a Page 3 for each feature.****1. Feature Description, Integrity, Eligibility:**

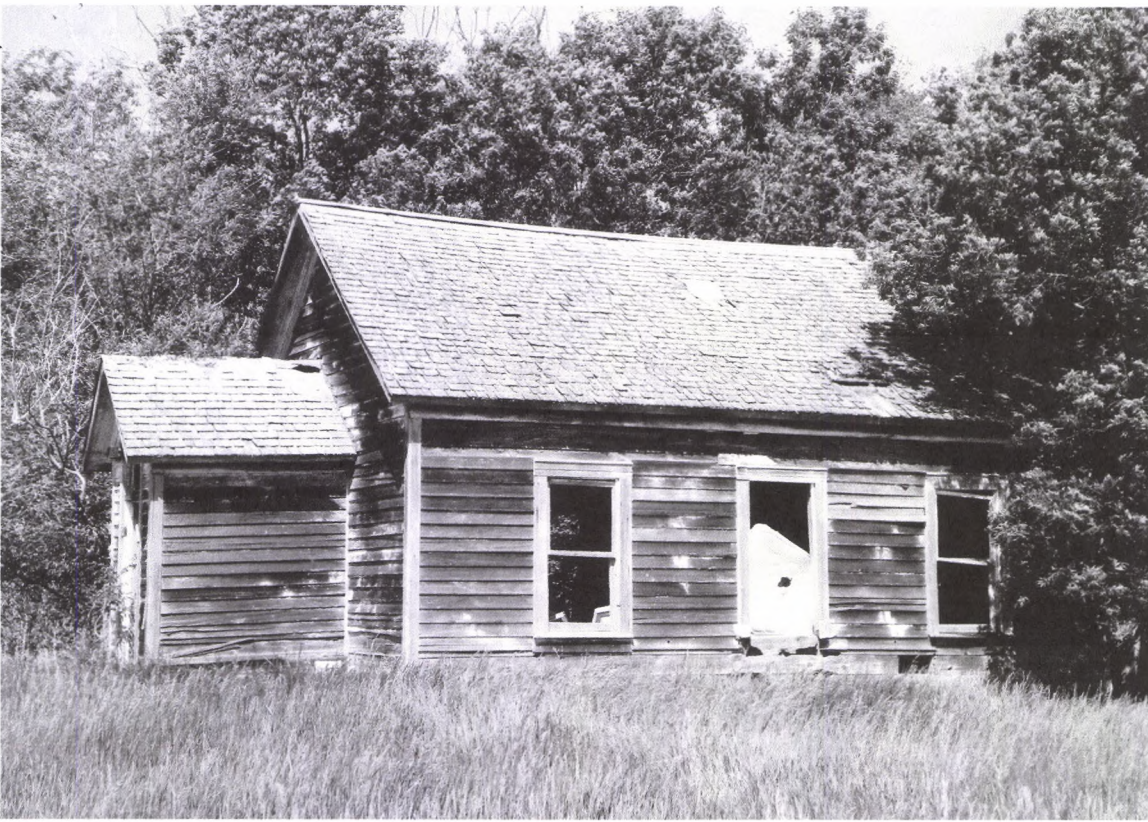
East Side

Hanson School sits on railroad ties in a farm yard, moved to serve as a storage shed. The school has wood shakes on the roof with metal capping and finials. Some of the wood shakes are gone and there is a covered hole where the chimney was. The soffits are closed. A wide trim board runs under the peak ends of the roof of the school as well as the entry. Siding is 6 inch wood lap with 6 inch wood corner trim, very little paint left. Some of the siding has been removed.

The entry door is missing and the school entry door is gone as well. There is a transom window space above the interior door with three more spaces about the transom that looked like they were fixed pane windows. No glass in any of these window spaces. There are three double hung windows on the west and east walls with little farming and no glass. One has a piece of plywood over the opening. There is also a hole in the northwest corner of the west wall, near the bottom of the wall. The inside of the entry has beadboard on the walls and ceiling. The inside main room walls were all stripped out. The floor is hardwood tongue and groove. There is no evidence of electricity in this building.
