NDCRS ARCHITECTURAL FORM

Site Name Oliver Township School

Site Name Stewart School

Century-old schoolhouse near Epping destroyed by wildfires

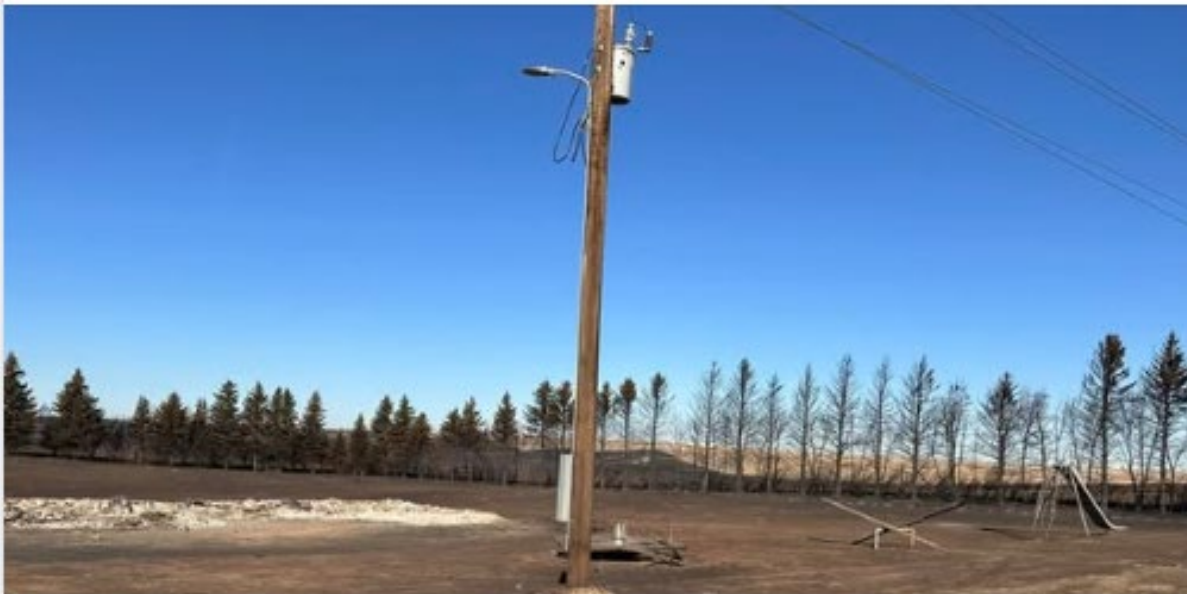
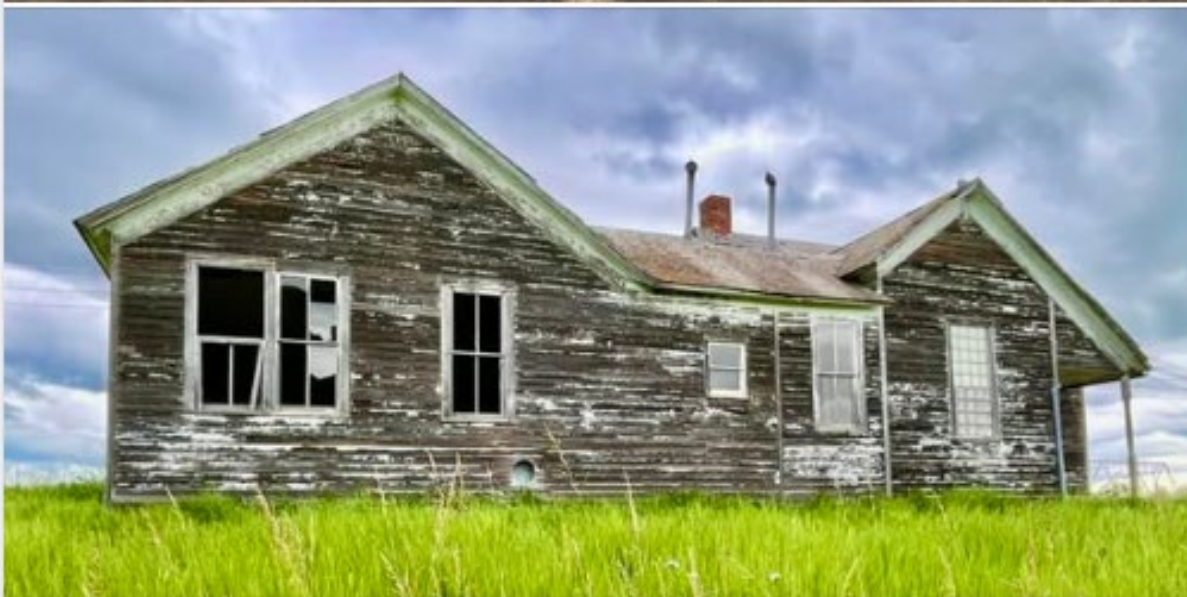
Figure 1: Post from Friends of Wabek Facebook page accessed 1/13/2025.

Friends of Wabek was about to restore the old Stewart School in Oliver Township north of Epping. This time next year, it would have looked like a new building, but now it's gone. Prayers to everyone affected by the fires.

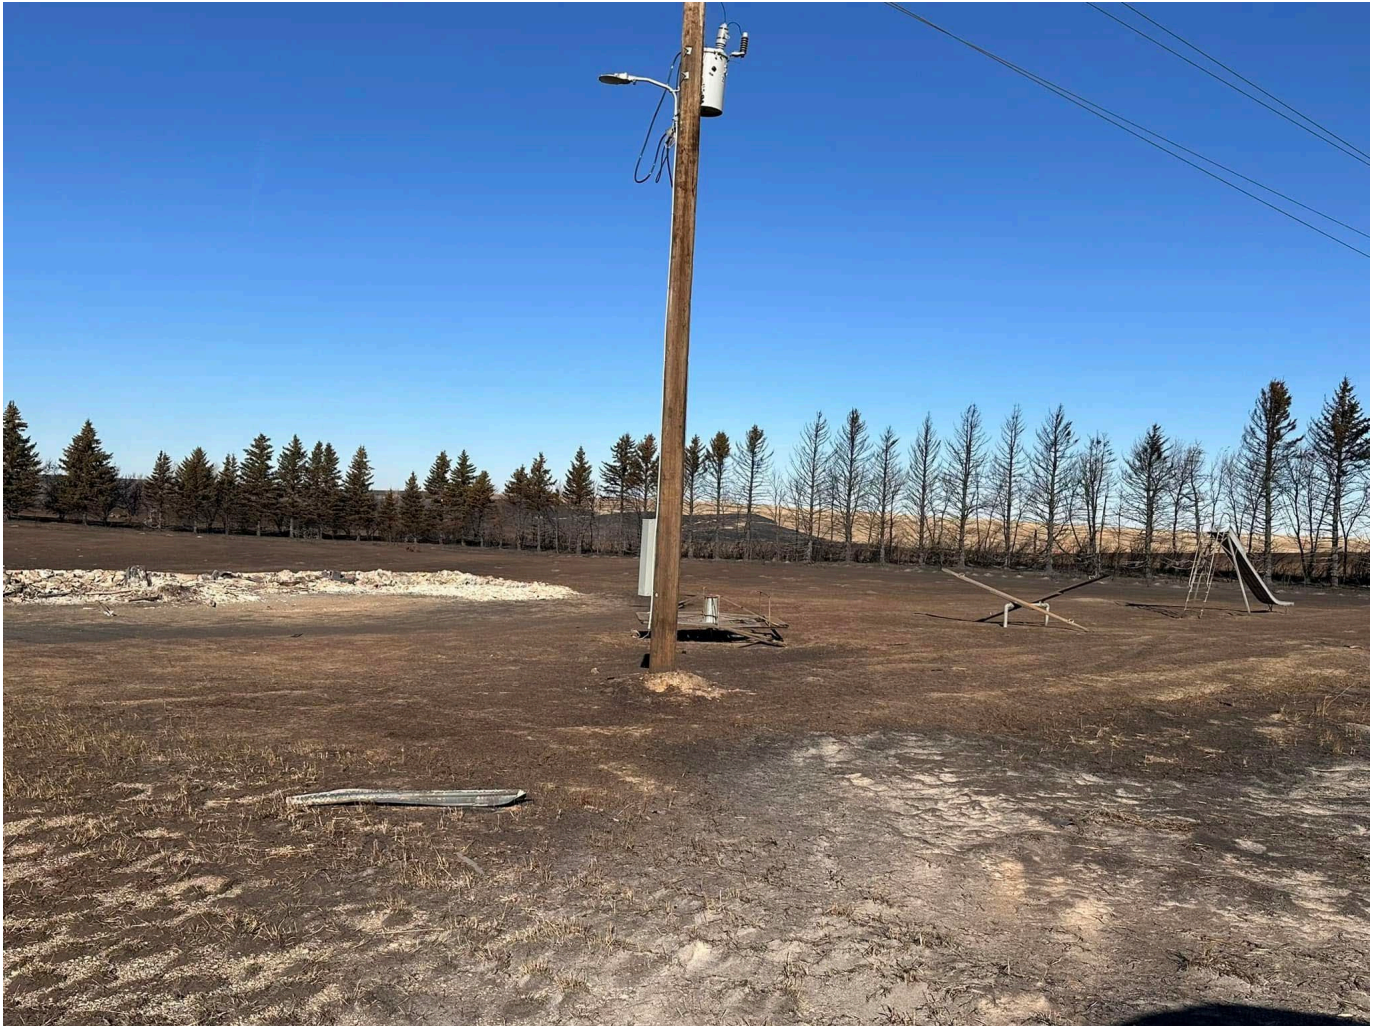
Figure 2: Image of schoolyard from Friends of Wabek Facebook group. Schoolhouse debris at left, view northwest.

Miscellaneous Information Destroyed by wildfire in October 2024**Feature Preservation Recommendation(s) (Check all that apply):**☐ Individual nomination☐ Contributes to a potential district☐ No nomination potential☐ Will not contribute to a district☐ Potential district—feature would be a contributing element if other properties constitute a district☐ Thematic nomination potential☐ Component of a historic site or landscape☐ Moved (specify all applicable choices)—a) relocation occurred within a historic period; b) recreates original site, orientation, landscape, and spatial relationships; c) compatible in context with neighboring structures; d) relocation has damaged eligibility☐ Historical associations require further investigation**Recorded By:** E. Scherr, SHSND **Date Recorded:** 01/13/2025

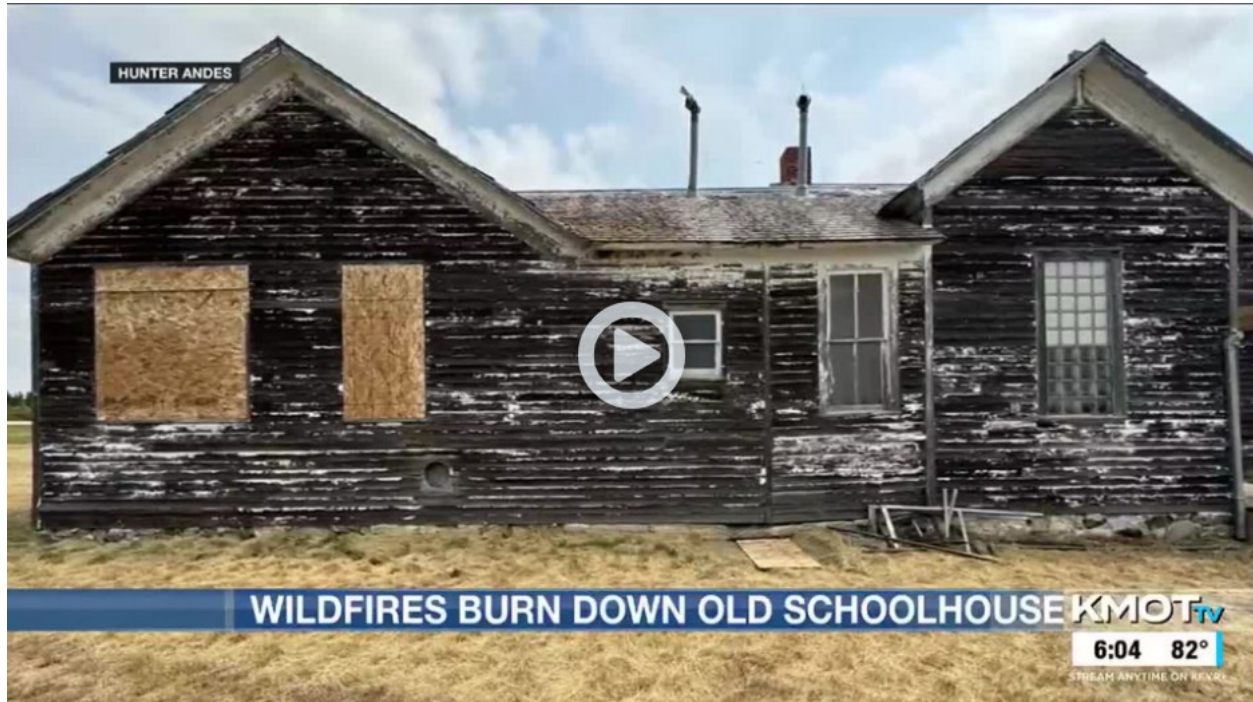
The Stewart School in Oliver Township, which was set to be renovated sometime next year, was destroyed in this week's fires.

The Stewart School near Epping burned down over the weekend.

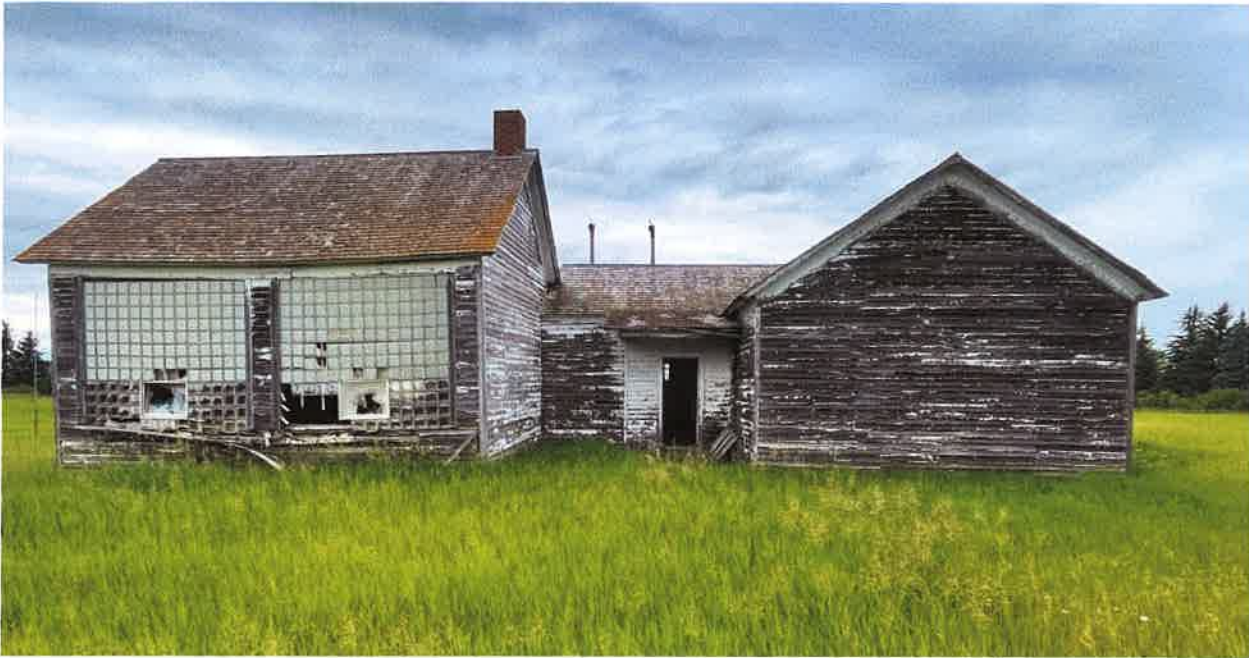
East Side

Update pictures show some damage to the lower part of the block glass windows on the east side of the south half of the school. The remainder of the school is mostly unchanged.
