NDCRS ARCHITECTURAL SITE FORM PAGE 1

The feature is a one room prairie school on a poured concrete basement that has been overlayed with stucco. The hip roof as well as the gable entry roof are covered with wood shakes and metal capping with finials. The soffits are closed with beadboard. The chimney is gone. The building measures 36 feet east to west and 20 feet north to south.

Orthell Township School

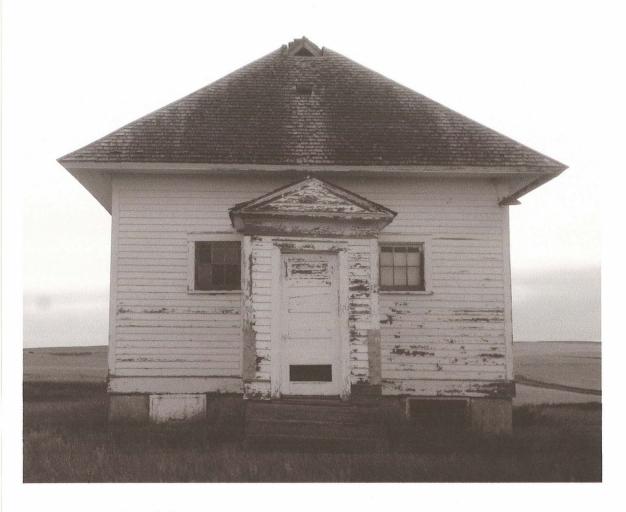
East Side

There is a wide trim board under the soffits on all four sides of the school and entry. The remaining siding is 6 inch wood lap with 6 inch corner trim to a waterboard and skirting board at the bottom. On the east side of the school, on the south side of the entry is a fuel door and the north side a window opening. On the west side basement level there are three multipane windows, on the north side two sets of two multipane windows and two more windows on the south side with one of these covered. There are two smaller, 6 pane fixed windows to either side of the entry. The south side has two sets of three large, multipane windows with some covered and much of the glass gone. Concrete steps lead to a concrete stoop and the broken 5 panel wood door. There is a window opening on the south side of the entry, no glass or framing. The entry leads into a large coat room with a door toward the north side leading to the basement stairway. Another door leads into the school room. The interior walls are wallboard with a wide trim board at the bottom. There is a picture rail on all walls. The ceiling is lathe and plaster. The floor is hardwood coverd with tile. There are blackboards on the entire north wall of the school room and on the entry wall between the door and a built in cupboard. Globe light fixtures and wiring suggest electricity.
