NDCRS ARCHITECTURAL SITE FORM

Field Code Museum School #2

SITS# 32 WI 2343

Project & Principal Investigator:
Country Schoolhouse Project

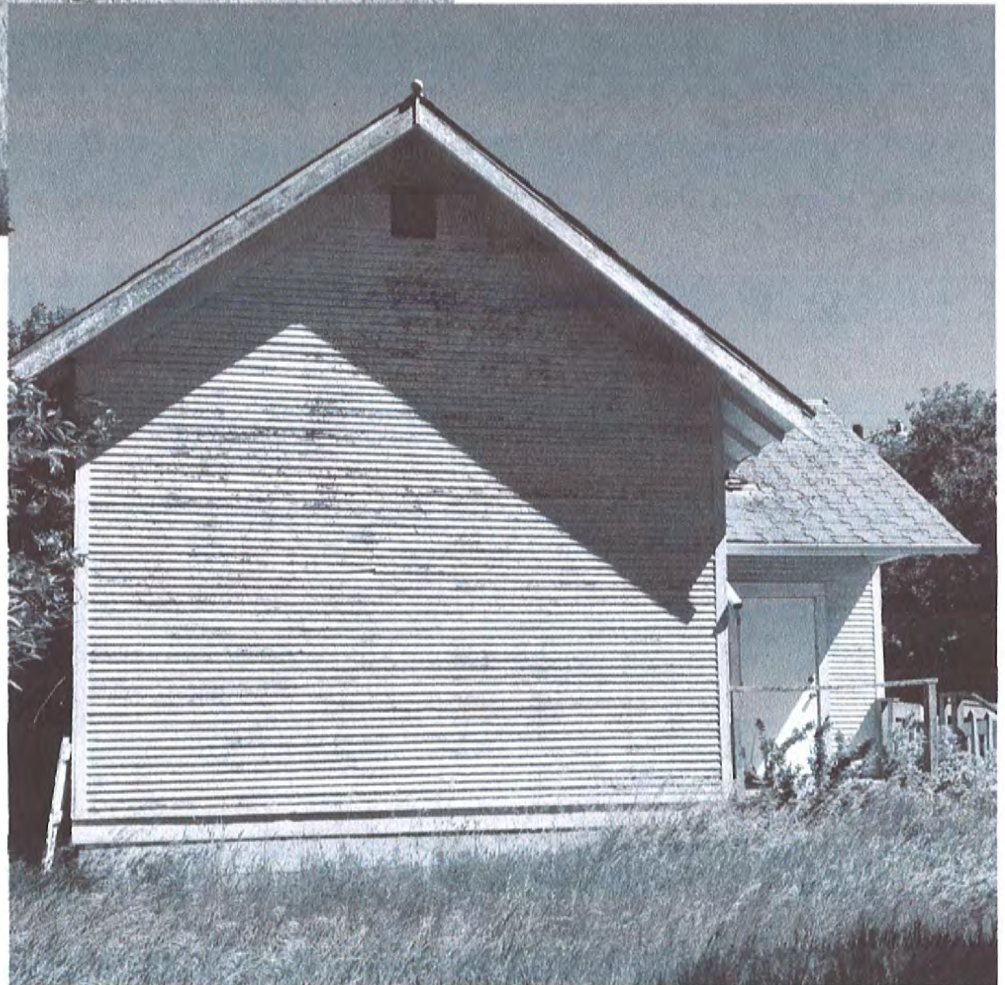
South Side

A frieze board can be see under the eaves of all the peaks. The siding is 4 inch wood lap with 4 inch wood corner trim. An overhang protects the south facing solid core door. An eaves trough as at the outer edge of this part of the roof. There is one new large window, the window has a large pane of glass on the top and two small sliding windows on the bottom, on the east side of the entry. The entry can be reached by either steps off the south of the porch or by a ramp leading up along the east wall. The entry and large room are covered with vinyl. The walls and ceiling are covered with wallboard. A picture rail is on the wall in the main room. There are two more windows with a large piece of glass at the top and two smaller windows at the bottom one of which is a slider. This building has lots of museum storage.
