NDCRS ARCHITECTURAL FORM  
PAGE 1

Site Name Thull School

Country School House Project  
Kathy Wilner  
366 43rd Ave SE  
Bowdon ND 58418

Architectural Feature # 1

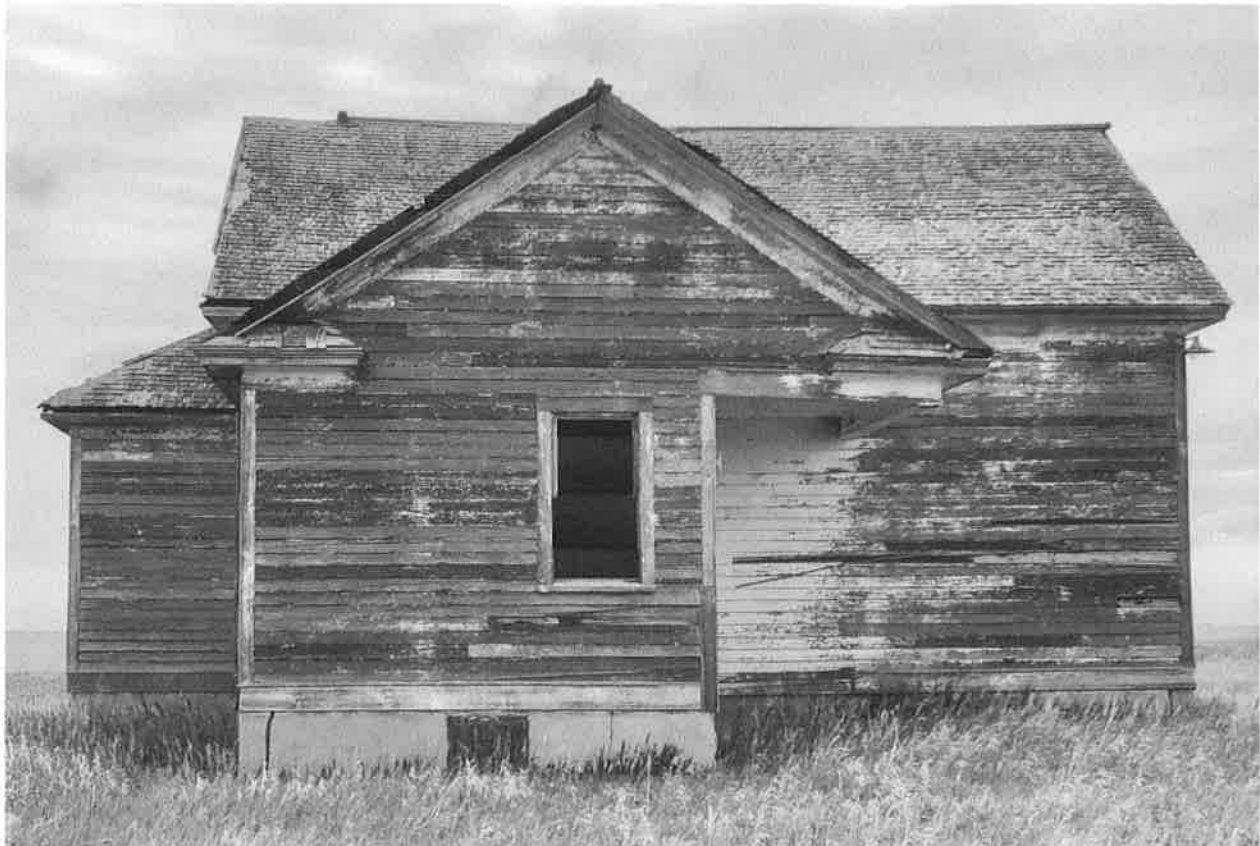
West Side

A rake board begins the siding under the eaves on all sides of the school. The remainder of the siding is 6 inch wood lap with 6 inch wood corner trim with waterboard at the bottom. There is an entry on the west side with double doors. The porch is gone. The exterior doors are three panel wood with window openings on each. There are two window openings in the entry, one faces west and the other north. Inside the entry the walls have wainscot and two more 5 panel wood doors leading into the school room. Two small double hung window openings are located on the north wall of the bathroom. Two large double hung 4 over 4 windows are in the school at either side of the bathroom. Similar windows are on the east side, they are grouped with three together either side of two in the middle. Little glass remains. A halfmoon window sits high on the south wall. The basement wall on the east side has fallen in. There are basement windows on the north, south and west sides. The walls are finished with wallboard. The ceiling was finished with rectangular tiles and many have fallen away. Large white globe lights in the school room indicate the presence of electricity. There are blackboards on the west and south walls of the school room. There is wainscot in the school room.
